School Assessment Report

Type: High Schools
School: Sterling High School
Date: Jul 16, 2012

School Name: Sterling High School

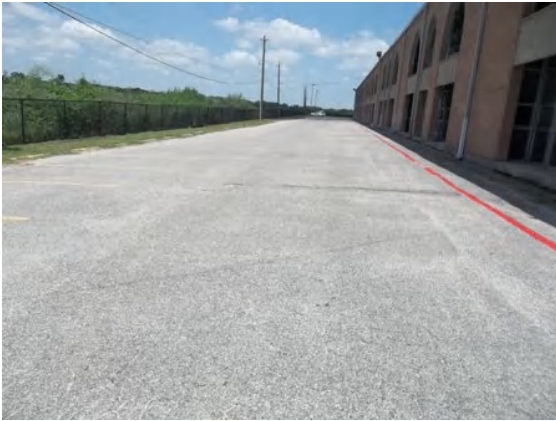
System: G2010 - Roadways

Analysis: The system age is either beyond expected life or does not meet its intended performance under the Guidelines. The system may be in service and functioning but it is recommended to be replaced due to probable increased condition budget needs, the potential failure of its components, or in order to meet the performance Guidelines for this system. The system was installed in 1980. It has a 25-year service life which expired in 2005.

Notes: Roadways System beyond useful life. Replace

Recommendation: The system should be replaced.

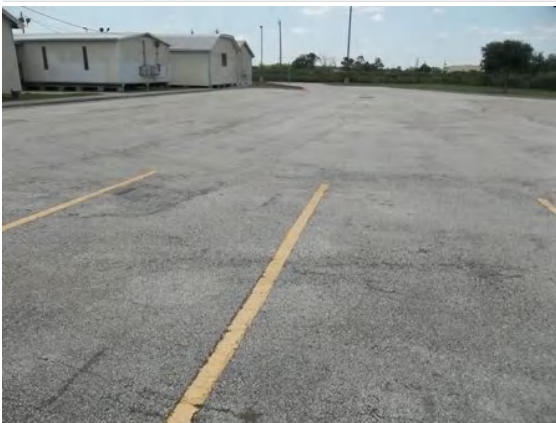
System: G2020 - Parking Lots

Analysis: The system age is either beyond expected life or does not meet its intended performance under the Guidelines. The system may be in service and functioning but it is recommended to be replaced due to probable increased condition budget needs, the potential failure of its components, or in order to meet the performance Guidelines for this system. The system was installed in 1980. It has a 25-year service life which expired in 2005.

Notes: Parking Lots System beyond useful life. Replace

Recommendation: The system should be replaced.

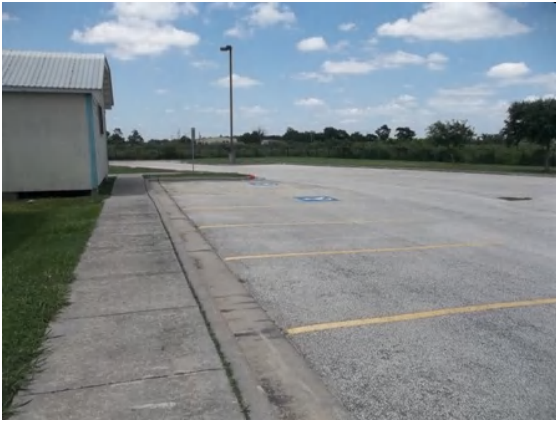
System: G2020 - Pedestrian Paving - sidewalks, etc

Analysis: The system age is either beyond expected life or does not meet its intended performance under the Guidelines. The system may be in service and functioning but it is recommended to be replaced due to probable increased condition budget needs, the potential failure of its components, or in order to meet the performance Guidelines for this system. The system was installed in 1980. It has a 30-year service life which expired in 2010.

Notes: Pedestrian Paving - sidewalks System beyond useful life. Replace

Recommendation: The system should be replaced.

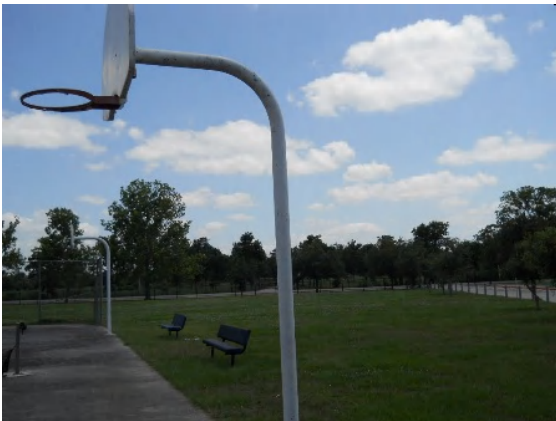
System: G2040 - Basketball / hard court play area

Analysis: The system age is either beyond expected life or does not meet its intended performance under the Guidelines. The system may be in service and functioning but it is recommended to be replaced due to probable increased condition budget needs, the potential failure of its components, or in order to meet the performance Guidelines for this system. The system was installed in 1965. It has a 10-year service life which expired in 1975.

Notes: Basketball / hard court play area System Beyond Useful life. Replace

Recommendation: The system should be replaced.

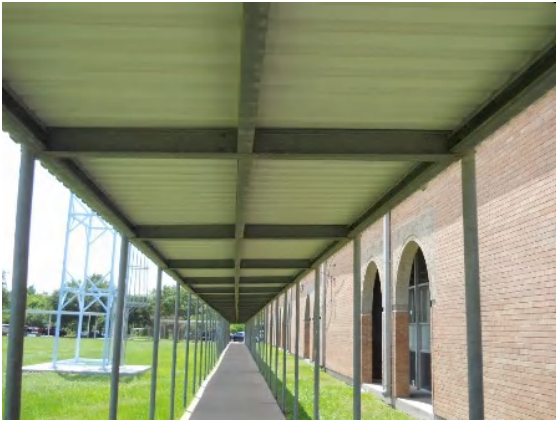
System: G2040 - Canopy

Analysis: The system age is either beyond expected life or does not meet its intended performance under the Guidelines. The system may be in service and functioning but it is recommended to be replaced due to probable increased condition budget needs, the potential failure of its components, or in order to meet the performance Guidelines for this system. The system was installed in 1965. It has a 30-year service life which expired in 1995.

Notes: Canopy System Beyond Useful life. Replace

Recommendation: The system should be replaced.

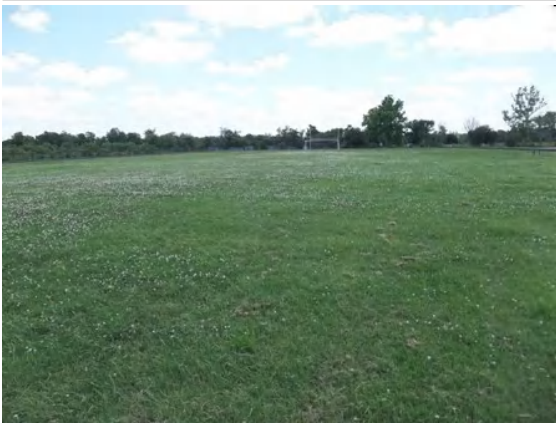
System: G2040 - Football Field Natural Turf

Analysis: The system age is either beyond expected life or does not meet its intended performance under the Guidelines. The system may be in service and functioning but it is recommended to be replaced due to probable increased condition budget needs, the potential failure of its components, or in order to meet the performance Guidelines for this system. The system was installed in 2000. It has a 10-year service life which expired in 2010.

Notes: Football Field Natural Turf Furnishings System beyond useful life. Replace

Recommendation: The system should be replaced.

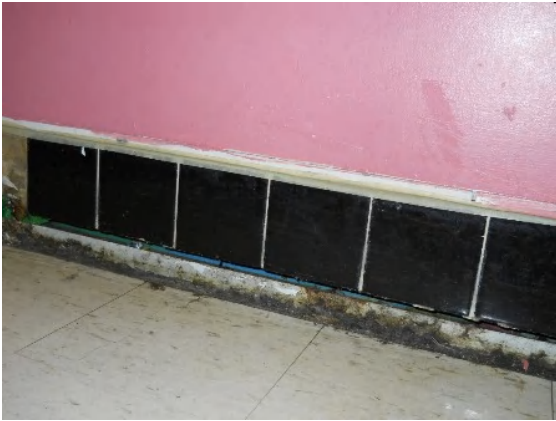
System: A1010 - Standard Foundations

Analysis: The system is in use and functioning with an estimated remaining service life as indicated in the report section "Condition/Replacement Budget Detail". The system was installed in 1965. It has a 100-year service life. However, in the assessment, it was found to be currently deficient and is non-renewable.

Distress: Failing

Notes: Foundation failing under bearing wall in classroom wing.

Recommendation: The system should be replaced.

Correction: Professional Service - Investigate Foundation

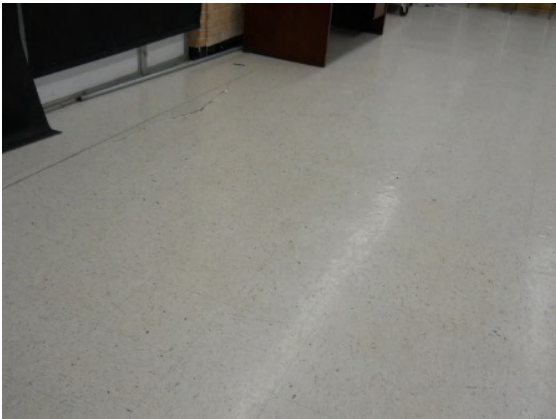
System: A1030 - Slab on Grade

Analysis: The system is in use and functioning with an estimated remaining service life as indicated in the report section "Condition/Replacement Budget Detail". The system was installed in 1965. It has a 100-year service life. However, in the assessment, it was found to be currently deficient and is non-renewable.

Distress: Failing

Notes: concrete slab on grade is sinking sub grade is damaged as well.

Recommendation: The system should be replaced.

Correction: Replace concrete slab as required

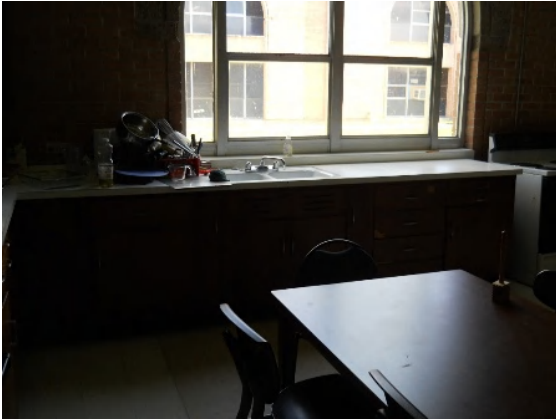
System: B2020 - Exterior Windows

Analysis: The system age is either beyond expected life or does not meet its intended performance under the Guidelines. The system may be in service and functioning but it is recommended to be replaced due to probable increased condition budget needs, the potential failure of its components, or in order to meet the performance Guidelines for this system. The system was installed in 1965. It has a 30-year service life which expired in 1995.

Recommendation: The system should be replaced.

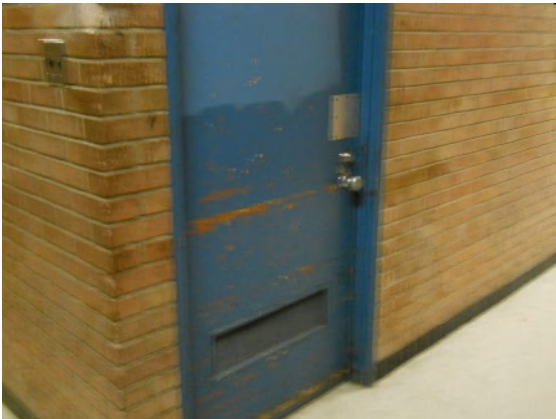
System: B2030 - Exterior Doors

Analysis: The system age is either beyond expected life or does not meet its intended performance under the Guidelines. The system may be in service and functioning but it is recommended to be replaced due to probable increased condition budget needs, the potential failure of its components, or in order to meet the performance Guidelines for this system. The system was installed in 1965. It has a 30-year service life which expired in 1995.

Notes: Exterior Doors System beyond useful life. Replace

Recommendation: The system should be replaced.

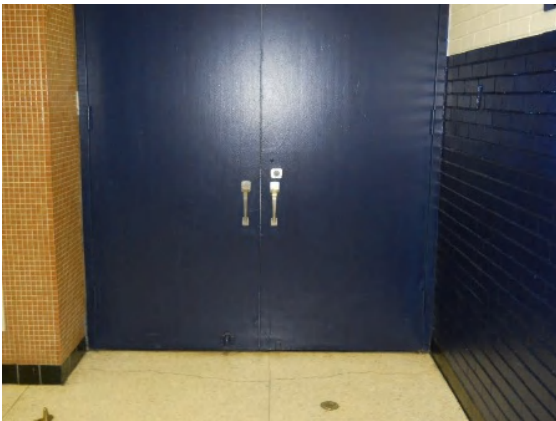
System: C1020 - Interior Doors

Analysis: The system age is either beyond expected life or does not meet its intended performance under the Guidelines. The system may be in service and functioning but it is recommended to be replaced due to probable increased condition budget needs, the potential failure of its components, or in order to meet the performance Guidelines for this system. The system was installed in 1965. It has a 20-year service life which expired in 1985.

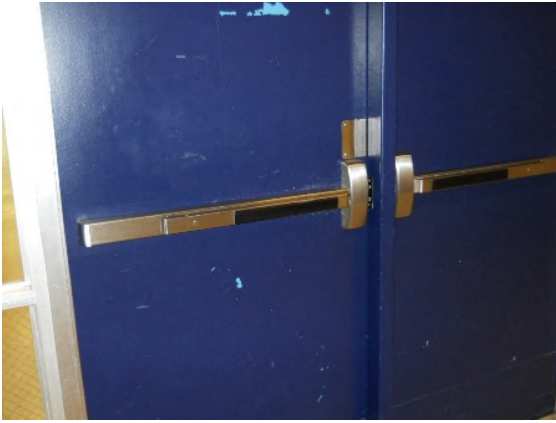
System: C1030 - Fittings

Analysis: The system age is either beyond expected life or does not meet its intended performance under the Guidelines. The system may be in service and functioning but it is recommended to be replaced due to probable increased condition budget needs, the potential failure of its components, or in order to meet the performance Guidelines for this system. The system was installed in 1965. It has a 15-year service life which expired in 1980.

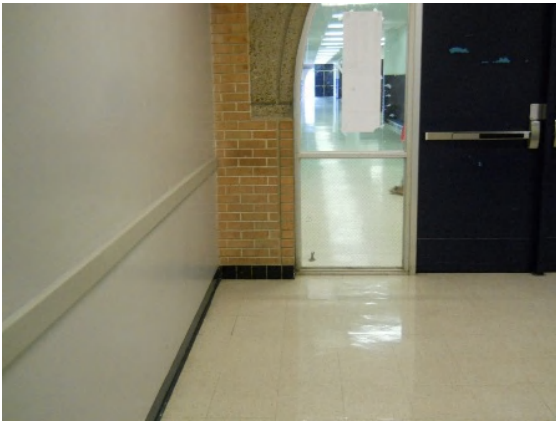
System: C3010 - Wall Finishes

Analysis: The system age is either beyond expected life or does not meet its intended performance under the Guidelines. The system may be in service and functioning but it is recommended to be replaced due to probable increased condition budget needs, the potential failure of its components, or in order to meet the performance Guidelines for this system. The system was installed in 1998. It has a 10-year service life which expired in 2008.

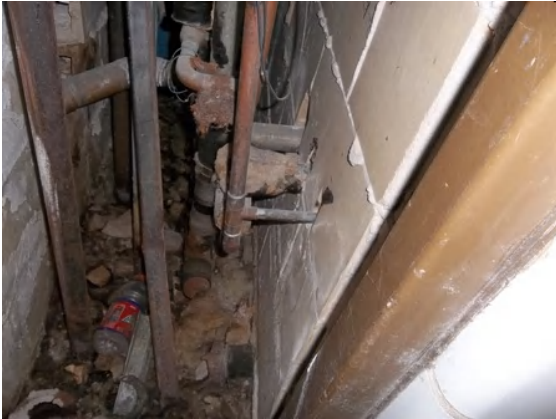
System: D2030 - Sanitary Waste

Analysis: The system age is either beyond expected life or does not meet its intended performance under the Guidelines. The system may be in service and functioning but it is recommended to be replaced due to probable increased condition budget needs, the potential failure of its components, or in order to meet the performance Guidelines for this system. The system was installed in 1965. It has a 30-year service life which expired in 1995.

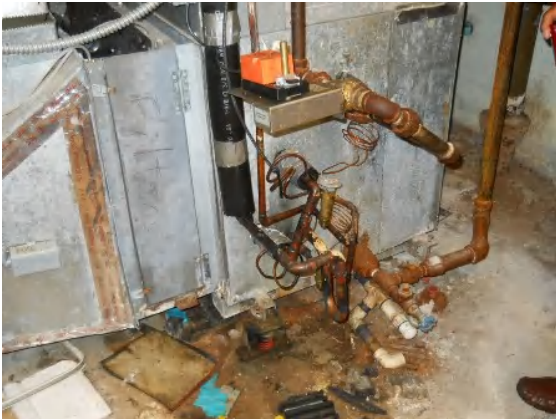
System: D2090 - Other Plumbing Systems-Nat Gas

Analysis: The system age is either beyond expected life or does not meet its intended performance under the Guidelines. The system may be in service and functioning but it is recommended to be replaced due to probable increased condition budget needs, the potential failure of its components, or in order to meet the performance Guidelines for this system. The system was installed in 1965. It has a 20-year service life which expired in 1985.

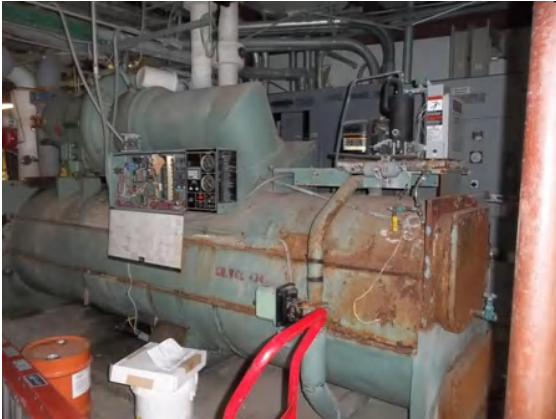
System: D3030 - Cooling Generating Systems

Analysis: The system age is either beyond expected life or does not meet its intended performance under the Guidelines. The system may be in service and functioning but it is recommended to be replaced due to probable increased condition budget needs, the potential failure of its components, or in order to meet the performance Guidelines for this system. The system was installed in 1965. It has a 20-year service life which expired in 1985.
