School Assessment Report

Type: High Schools
School: Bellaire High School
Date: Jul 16, 2012

School Name: Bellaire High School

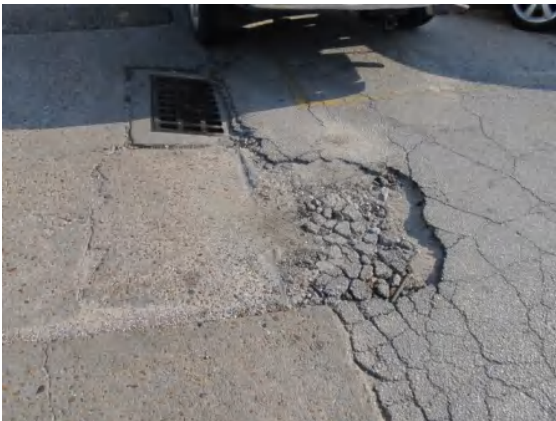
System: G2020 - Parking Lots

Analysis: The system is in use and functioning with an estimated remaining service life as indicated in the report section "Condition/Replacement Budget Detail". The system was installed in 1955. It has a 25-year service life which expired in 1980. However, based on the 2009 assessment, the service life has been extended to 2017.

Notes: The faculty and student parking lots are no longer able to handle the current school population. The asphalt is developing pot holes and the asphalt has become loose in some areas.

Recommendation: The system should be replaced.

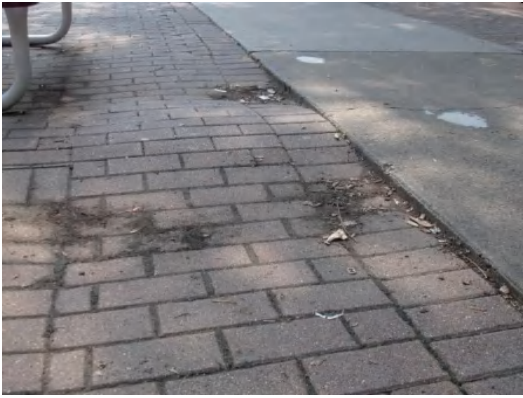
Notes: The sidewalks throughout the campus are in severe distress. There are signs of ground shift, uneven and rippling sidewalks making it a safety hazard. There are significant dips in the common areas of the campus.

Recommendation: The system should be replaced.

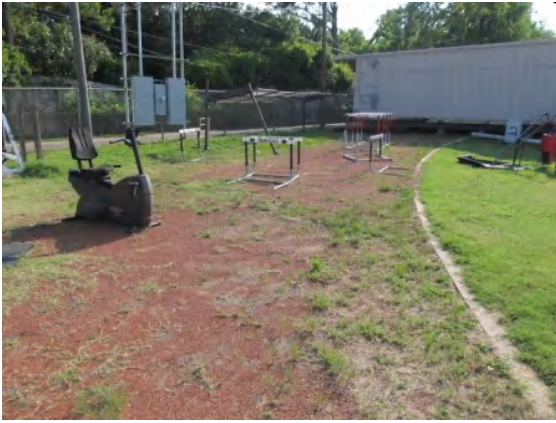
System: G2040 - Track Synthetic Surface - Replace

Analysis: The system age is either beyond expected life or does not meet its intended performance under the Guidelines. The system may be in service and functioning but it is recommended to be replaced due to probable increased condition budget needs, the potential failure of its components, or in order to meet the performance Guidelines for this system. The system was installed in 1955. It has a 10-year service life which expired in 1965.

Recommendation: The system should be replaced.

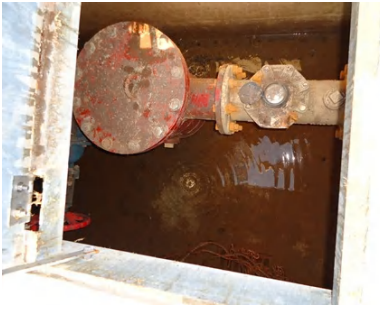
Notes: The domestic water laterals are aged, corroded, have periodic outages and should be replaced.

Recommendation: The system should be replaced.

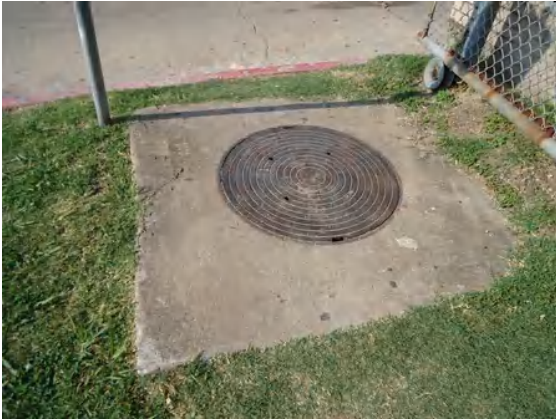
System: G3020 - Sanitary Sewer

Analysis: The system age is either beyond expected life or does not meet its intended performance under the Guidelines. The system may be in service and functioning but it is recommended to be replaced due to probable increased condition budget needs, the potential failure of its components, or in order to meet the performance Guidelines for this system. The system was installed in 1955. It has a 50-year service life which expired in 2005.

Notes: The original sanitary sewer laterals are aged, have periodic outages and should be replaced.

Recommendation: The system should be replaced.

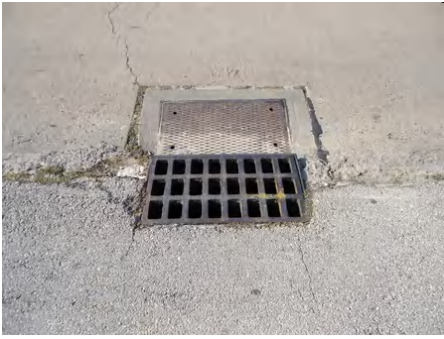
Notes: The storm drainage system is aged, worn, has reported drainage problems and should be replaced.

Recommendation: The system should be replaced.

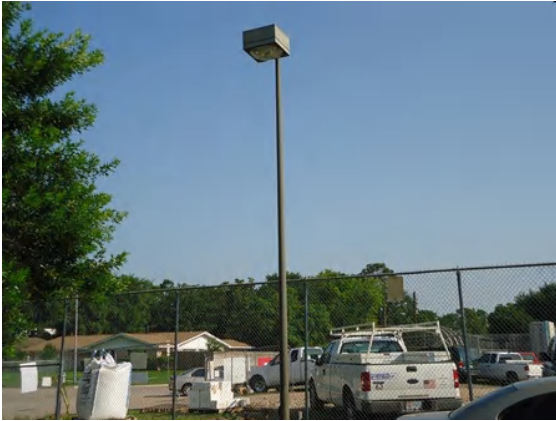
System: G4020 - Site Lighting

Analysis: The system age is either beyond expected life or does not meet its intended performance under the Guidelines. The system may be in service and functioning but it is recommended to be replaced due to probable increased condition budget needs, the potential failure of its components, or in order to meet the performance Guidelines for this system. The system was installed in 1955. It has a 30-year service life which expired in 1985.

Notes: Site lacks adequate site lighting. Existing lighting is aged, and should be replaced.

Recommendation: The system should be replaced.

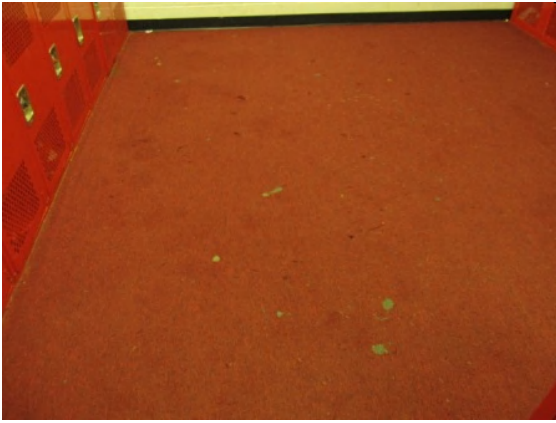
System: C3020210 - Carpet

Analysis: The system age is either beyond expected life or does not meet its intended performance under the Guidelines. The system may be in service and functioning but it is recommended to be replaced due to probable increased condition budget needs, the potential failure of its components, or in order to meet the performance Guidelines for this system. The system was installed in 1996. It has a 12-year service life which expired in 2008.

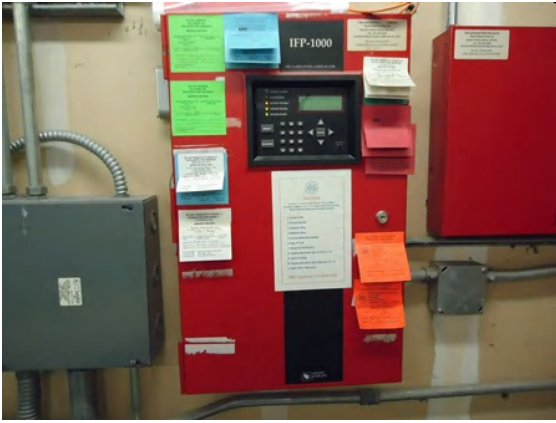
System: D5030910 - Fire Alarm System

Analysis: The system age is either beyond expected life or does not meet its intended performance under the Guidelines. The system may be in service and functioning but it is recommended to be replaced due to probable increased condition budget needs, the potential failure of its components, or in order to meet the performance Guidelines for this system. The system was installed in 1999. It has a 10-year service life which expired in 2009.

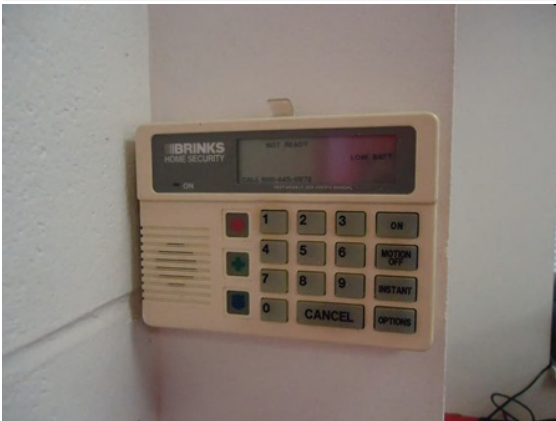
System: D5030910 - Security System, Camers, Access Control

Analysis: The system age is either beyond expected life or does not meet its intended performance under the Guidelines. The system may be in service and functioning but it is recommended to be replaced due to probable increased condition budget needs, the potential failure of its components, or in order to meet the performance Guidelines for this system. The system was installed in 1996. It has a 15-year service life which expired in 2011.

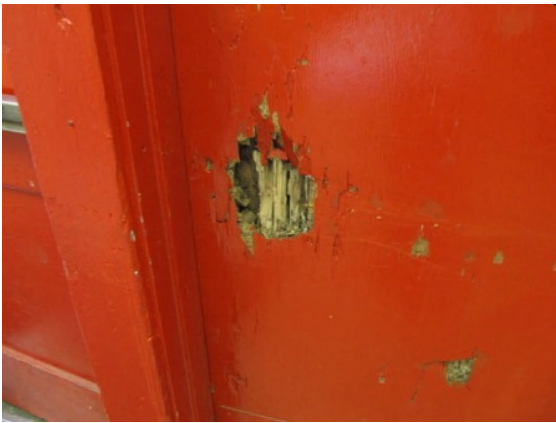
System: B2030 - Exterior Doors

Analysis: The system age is either beyond expected life or does not meet its intended performance under the Guidelines. The system may be in service and functioning but it is recommended to be replaced due to probable increased condition budget needs, the potential failure of its components, or in order to meet the performance Guidelines for this system. The system was installed in 1980. It has a 30-year service life which expired in 2010.

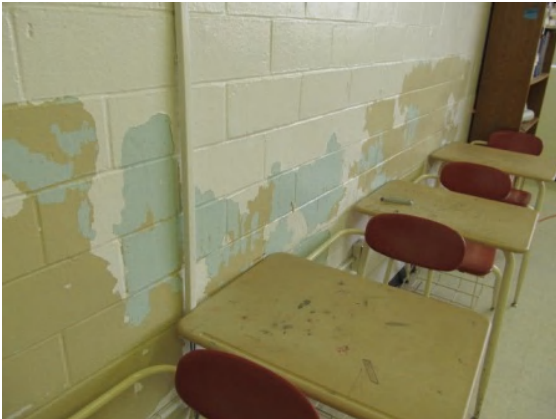
System: C3010 - Wall Finishes

Analysis: The system age is either beyond expected life or does not meet its intended performance under the Guidelines. The system may be in service and functioning but it is recommended to be replaced due to probable increased condition budget needs, the potential failure of its components, or in order to meet the performance Guidelines for this system. The system was installed in 2001. It has a 10-year service life which expired in 2011.

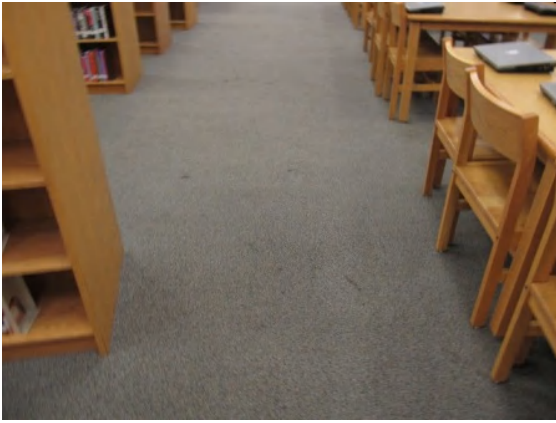
System: C3020210 - Carpet

Analysis: The system age is either beyond expected life or does not meet its intended performance under the Guidelines. The system may be in service and functioning but it is recommended to be replaced due to probable increased condition budget needs, the potential failure of its components, or in order to meet the performance Guidelines for this system. The system was installed in 1992. It has a 12-year service life which expired in 2004.

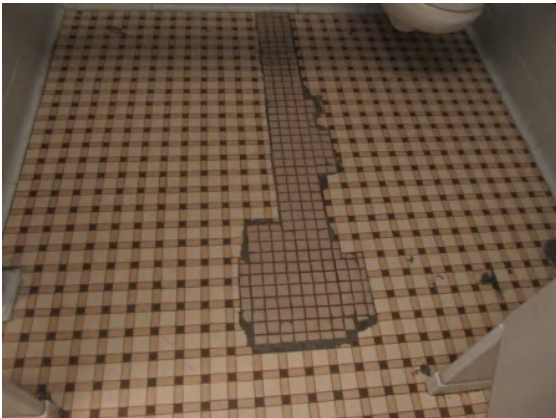
System: C3020210 - Ceramic Tile

Analysis: The system age is either beyond expected life or does not meet its intended performance under the Guidelines. The system may be in service and functioning but it is recommended to be replaced due to probable increased condition budget needs, the potential failure of its components, or in order to meet the performance Guidelines for this system. The system was installed in 1955. It has a 50-year service life which expired in 2005.

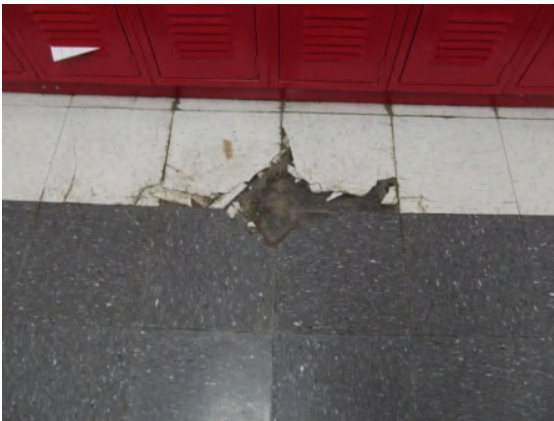
System: C3020410 - VCT

Analysis: The system is in use and functioning with an estimated remaining service life as indicated in the report section "Condition/Replacement Budget Detail". The system was installed in 2001. It has a 12-year service life. However, in the assessment, it was found to be currently deficient.

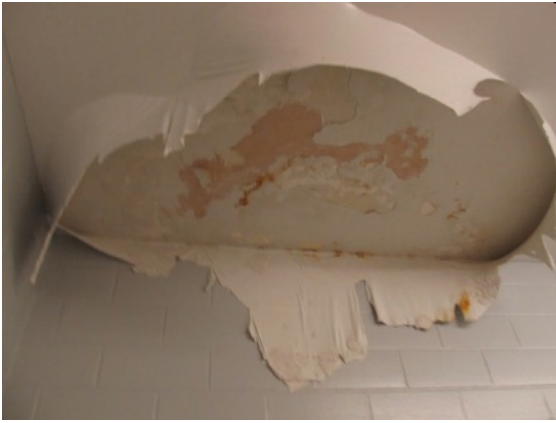
System: C3030 - Ceiling Finishes

Analysis: The system is in use and functioning with an estimated remaining service life as indicated in the report section "Condition/Replacement Budget Detail". The system was installed in 1992. It has a 20-year service life. However, in the assessment, it was found to be currently deficient.

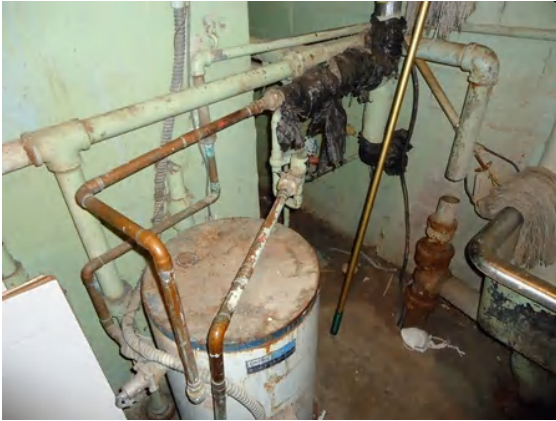
System: D2020 - Domestic Water Distribution

Analysis: The system age is either beyond expected life or does not meet its intended performance under the Guidelines. The system may be in service and functioning but it is recommended to be replaced due to probable increased condition budget needs, the potential failure of its components, or in order to meet the performance Guidelines for this system. The system was installed in 1955. It has a 30-year service life which expired in 1985.

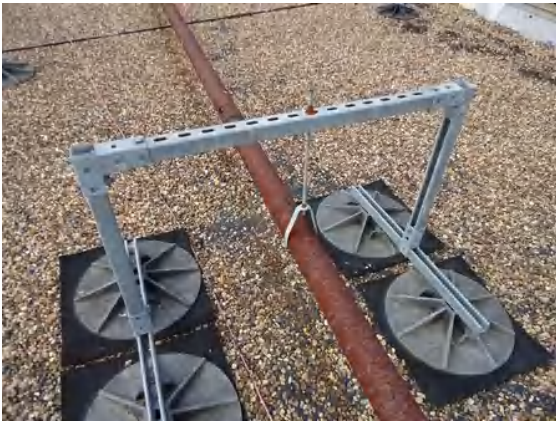
System: D2090 - Other Plumbing Systems-Nat Gas

Analysis: The system age is either beyond expected life or does not meet its intended performance under the Guidelines. The system may be in service and functioning but it is recommended to be replaced due to probable increased condition budget needs, the potential failure of its components, or in order to meet the performance Guidelines for this system. The system was installed in 1955. It has a 20-year service life which expired in 1975.

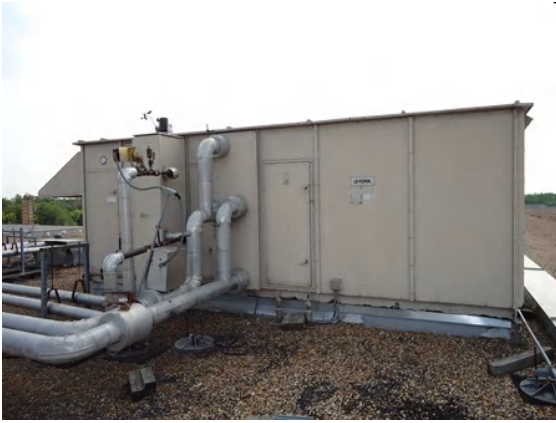
System: D3050 - Terminal & Package Units

Analysis: The system age is either beyond expected life or does not meet its intended performance under the Guidelines. The system may be in service and functioning but it is recommended to be replaced due to probable increased condition budget needs, the potential failure of its components, or in order to meet the performance Guidelines for this system. The system was installed in 1991. It has a 15-year service life which expired in 2006.

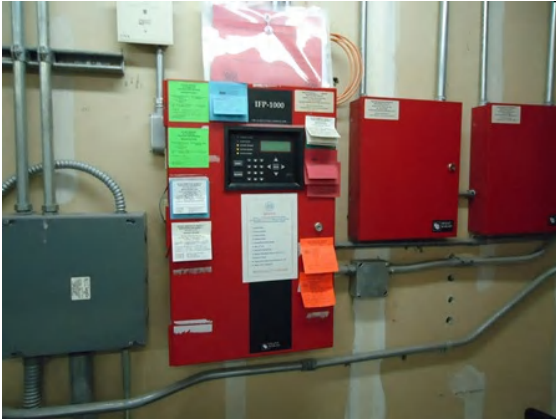
System: D5030910 - Fire Alarm System

Analysis: The system age is either beyond expected life or does not meet its intended performance under the Guidelines. The system may be in service and functioning but it is recommended to be replaced due to probable increased condition budget needs, the potential failure of its components, or in order to meet the performance Guidelines for this system. The system was installed in 2001. It has a 10-year service life which expired in 2011.

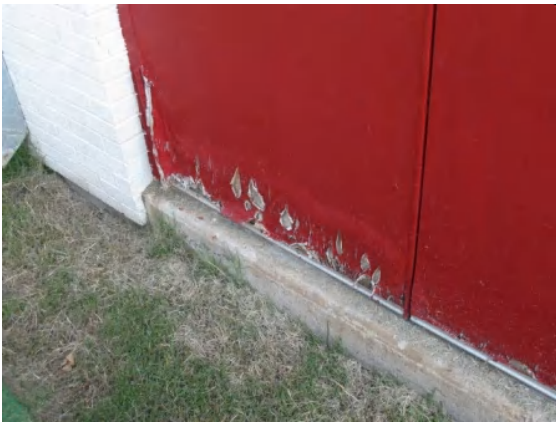
System: B2030 - Exterior Doors

Analysis: The system age is either beyond expected life or does not meet its intended performance under the Guidelines. The system may be in service and functioning but it is recommended to be replaced due to probable increased condition budget needs, the potential failure of its components, or in order to meet the performance Guidelines for this system. The system was installed in 1955. It has a 30-year service life which expired in 1985.

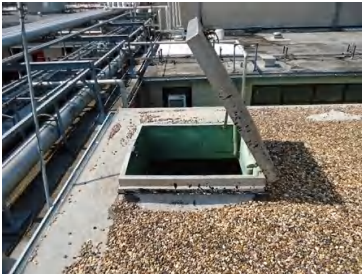
Location: Mechanical 01 - Bldg 03
Distress: Beyond Expected Life
Category: Deferred Maintenance
Priority: 3 - Short Term Conditions (2-3 Years)
Notes: The roof hatch is no longer code compliant.
Correction: Renew System
Qty: 1-Ea.
Condition Budget: \$184

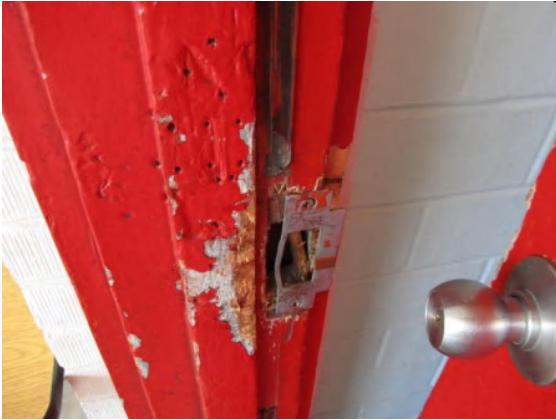
System: B2030 - Exterior Doors

Analysis: The system age is either beyond expected life or does not meet its intended performance under the Guidelines. The system may be in service and functioning but it is recommended to be replaced due to probable increased condition budget needs, the potential failure of its components, or in order to meet the performance Guidelines for this system. The system was installed in 1955. It has a 30-year service life which expired in 1985.

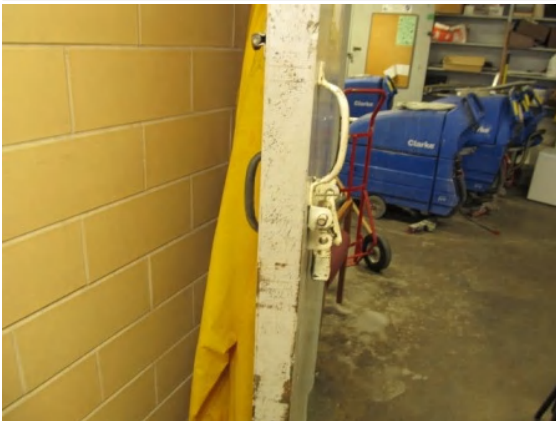
System: C1020 - Interior Doors

Analysis: The system age is either beyond expected life or does not meet its intended performance under the Guidelines. The system may be in service and functioning but it is recommended to be replaced due to probable increased condition budget needs, the potential failure of its components, or in order to meet the performance Guidelines for this system. The system was installed in 1955. It has a 40-year service life which expired in 1995.

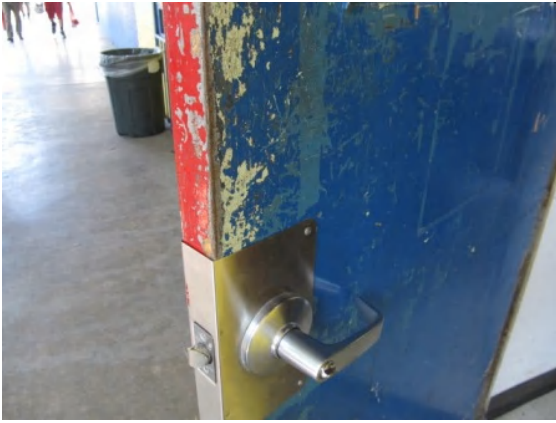
System: B2030 - Exterior Doors

Analysis: The system age is either beyond expected life or does not meet its intended performance under the Guidelines. The system may be in service and functioning but it is recommended to be replaced due to probable increased condition budget needs, the potential failure of its components, or in order to meet the performance Guidelines for this system. The system was installed in 1955. It has a 30-year service life which expired in 1985.

Recommendation: The system should be replaced.

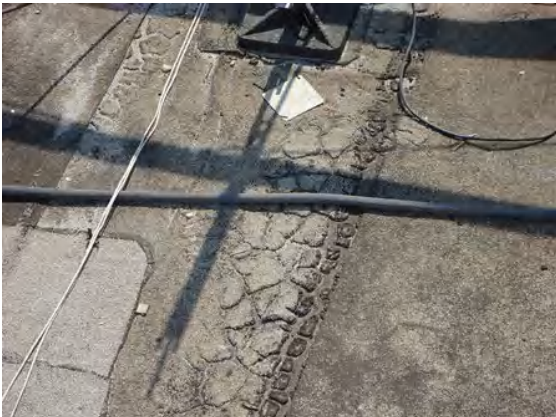
System: B3010630 - Modified Bitumen

Analysis: The system age is either beyond expected life or does not meet its intended performance under the Guidelines. The system may be in service and functioning but it is recommended to be replaced due to probable increased condition budget needs, the potential failure of its components, or in order to meet the performance Guidelines for this system. The system was installed in 1995. It has a 20-year service life. However, in the assessment, it was found to be currently deficient.

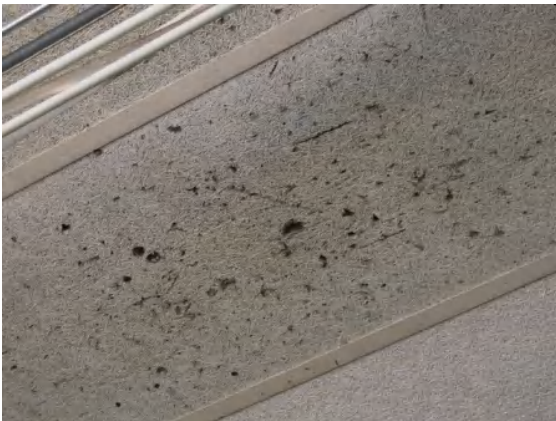
System: C3030 - Ceiling Finishes

Analysis: The system age is either beyond expected life or does not meet its intended performance under the Guidelines. The system may be in service and functioning but it is recommended to be replaced due to probable increased condition budget needs, the potential failure of its components, or in order to meet the performance Guidelines for this system. The system was installed in 1955. It has a 20-year service life which expired in 1975.

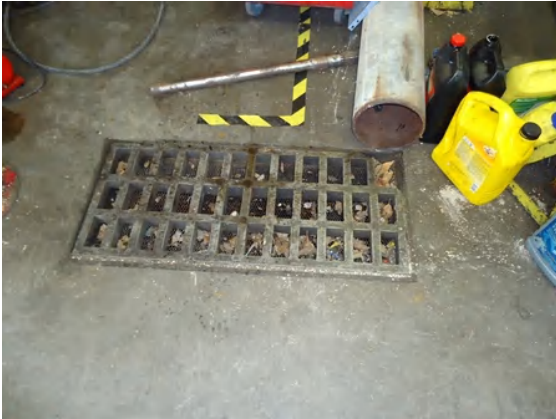
System: D2030 - Sanitary Waste

Analysis: The system age is either beyond expected life or does not meet its intended performance under the Guidelines. The system may be in service and functioning but it is recommended to be replaced due to probable increased condition budget needs, the potential failure of its components, or in order to meet the performance Guidelines for this system. The system was installed in 1955. It has a 30-year service life which expired in 1985.

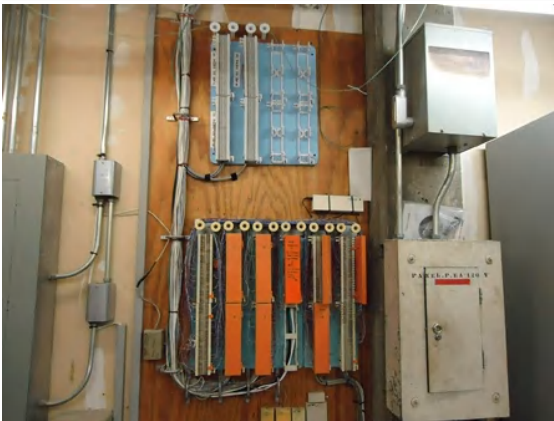
System: D5030310 - Telephone Systems

Analysis: The system age is either beyond expected life or does not meet its intended performance under the Guidelines. The system may be in service and functioning but it is recommended to be replaced due to probable increased condition budget needs, the potential failure of its components, or in order to meet the performance Guidelines for this system. The system was installed in 1991. It has a 15-year service life which expired in 2006.
