School Assessment Report

Type: High Schools
School: Worthing High School
Date: Jul 16, 2012

School Name: Worthing High School

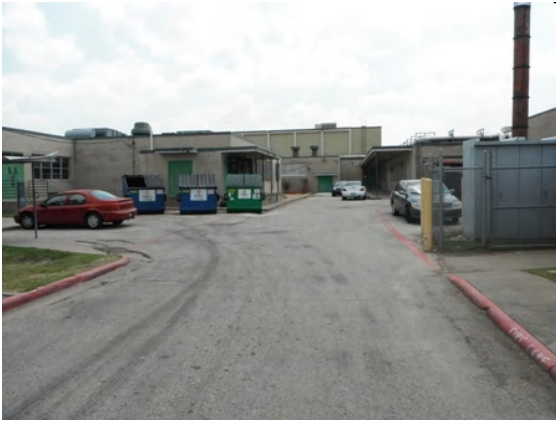
System: G2010 - Roadways

Analysis: The system age is either beyond expected life or does not meet its intended performance under the Guidelines. The system may be in service and functioning but it is recommended to be replaced due to probable increased condition budget needs, the potential failure of its components, or in order to meet the performance Guidelines for this system. The system was installed in 1959. It has a 25-year service life which expired in 1984.

Notes: Driveways and roadways are damaged, beyond useful life and require replacement.

Recommendation: The system should be replaced.

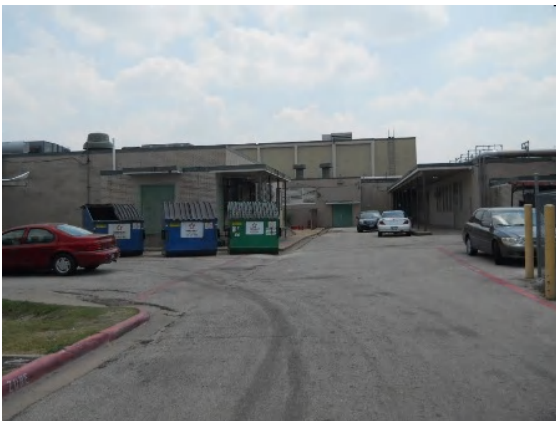
System: G2020 - Parking Lots

Analysis: The system age is either beyond expected life or does not meet its intended performance under the Guidelines. The system may be in service and functioning but it is recommended to be replaced due to probable increased condition budget needs, the potential failure of its components, or in order to meet the performance Guidelines for this system. The system was installed in 1959. It has a 25-year service life which expired in 1984.

Notes: The parking lots are beyond their useful life and require replacement.

Recommendation: The system should be replaced.

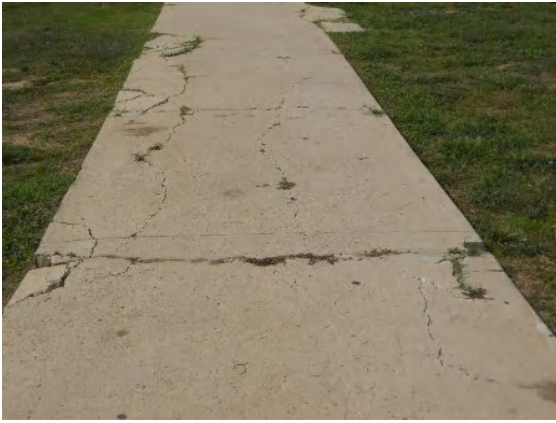
System: G2020 - Pedestrian Paving - sidewalks, etc

Analysis: The system age is either beyond expected life or does not meet its intended performance under the Guidelines. The system may be in service and functioning but it is recommended to be replaced due to probable increased condition budget needs, the potential failure of its components, or in order to meet the performance Guidelines for this system. The system was installed in 1959. It has a 30-year service life which expired in 1989.

Notes: The sidewalks are cracked, uneven and require replacement.

Recommendation: The system should be replaced.

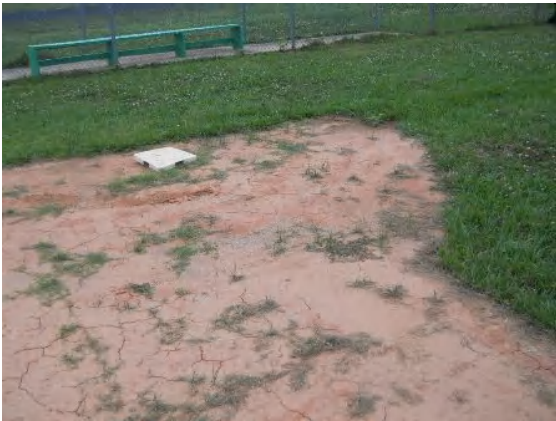
System: G2040 - Baseball Field

Analysis: The system age is either beyond expected life or does not meet its intended performance under the Guidelines. The system may be in service and functioning but it is recommended to be replaced due to probable increased condition budget needs, the potential failure of its components, or in order to meet the performance Guidelines for this system. The system was installed in 1981. It has a 30-year service life which expired in 2011.

Notes: The baseball field has not been maintained, is overgrown, and requires replacement.

Recommendation: The system should be replaced.

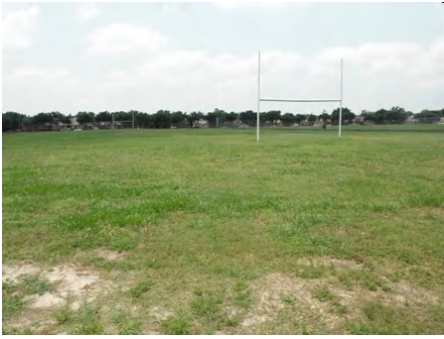
Analysis: The system age is either beyond expected life or does not meet its intended performance under the Guidelines. The system may be in service and functioning but it is recommended to be replaced due to probable increased condition budget needs, the potential failure of its components, or in order to meet the performance Guidelines for this system. The system was installed in 1981. It has a 10-year service life which expired in 1991.

Notes: The football field has not been maintained. There are no markings, and the posts require replacement. The field needs to be reworked.

Recommendation: The system should be replaced.

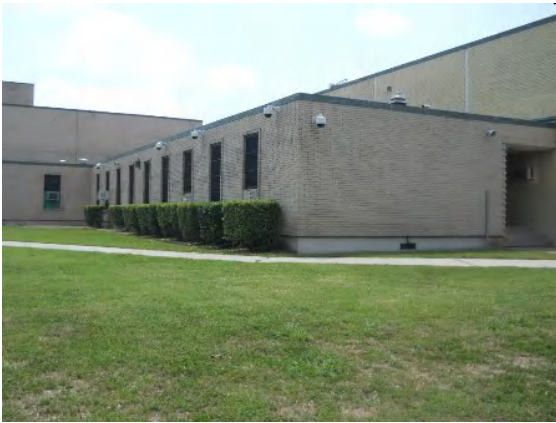
System: G2040 - Site Development

Analysis: The system age is either beyond expected life or does not meet its intended performance under the Guidelines. The system may be in service and functioning but it is recommended to be replaced due to probable increased condition budget needs, the potential failure of its components, or in order to meet the performance Guidelines for this system. The system was installed in 1959. It has a 30-year service life which expired in 1989.

Notes: The site landscaping, layout and usefulness is a candidate for replacement.

Recommendation: The system should be replaced.

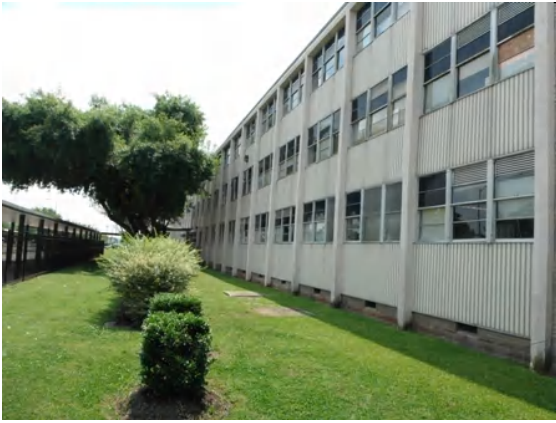
System: G3010 - Water Supply

Analysis: The system age is either beyond expected life or does not meet its intended performance under the Guidelines. The system may be in service and functioning but it is recommended to be replaced due to probable increased condition budget needs, the potential failure of its components, or in order to meet the performance Guidelines for this system. The system was installed in 1959. It has a 50-year service life which expired in 2009.

Notes: There is no backflow preventer on the site potable water supply and the water lateral is original, beyond expected service life and should be replaced with a backflow preventer added.

Recommendation: The system should be replaced.

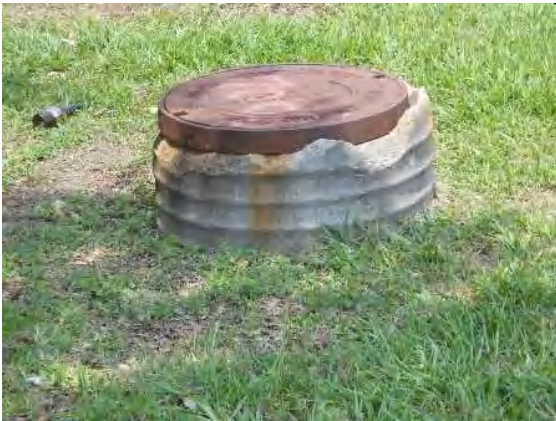
System: G3020 - Sanitary Sewer

Analysis: The system age is either beyond expected life or does not meet its intended performance under the Guidelines. The system may be in service and functioning but it is recommended to be replaced due to probable increased condition budget needs, the potential failure of its components, or in order to meet the performance Guidelines for this system. The system was installed in 1959. It has a 50-year service life which expired in 2009.

Notes: The original sanitary sewer system is beyond useful life and should be replaced.

Recommendation: The system should be replaced.

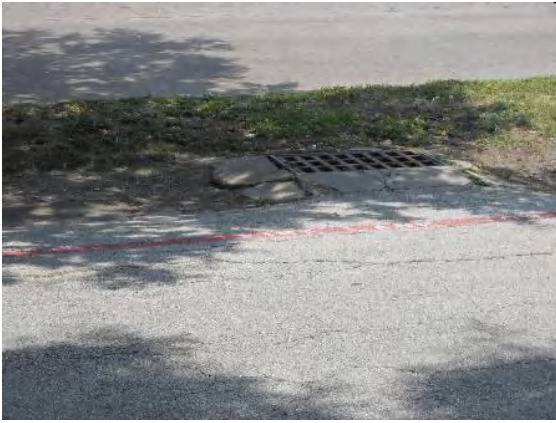
System: G3030 - Storm Sewer

Analysis: The system age is either beyond expected life or does not meet its intended performance under the Guidelines. The system may be in service and functioning but it is recommended to be replaced due to probable increased condition budget needs, the potential failure of its components, or in order to meet the performance Guidelines for this system. The system was installed in 1959. It has a 50-year service life which expired in 2009.

Notes: The storm sewer system is beyond it's expected service liffe and should be replaced.

Recommendation: The system should be replaced.

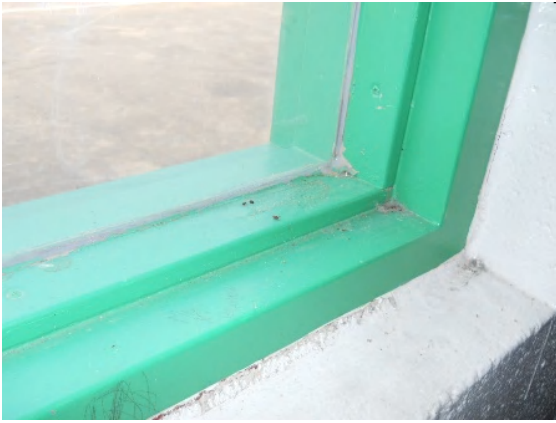
System: B2020 - Exterior Windows

Analysis: The system age is either beyond expected life or does not meet its intended performance under the Guidelines. The system may be in service and functioning but it is recommended to be replaced due to probable increased condition budget needs, the potential failure of its components, or in order to meet the performance Guidelines for this system. The system was installed in 1980. It has a 30-year service life which expired in 2010.

Recommendation: The system should be replaced.

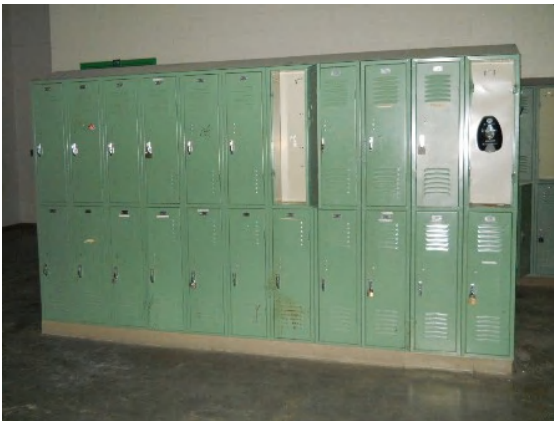
System: C1030 - Fittings

Analysis: The system age is either beyond expected life or does not meet its intended performance under the Guidelines. The system may be in service and functioning but it is recommended to be replaced due to probable increased condition budget needs, the potential failure of its components, or in order to meet the performance Guidelines for this system. The system was installed in 1980. It has a 20-year service life which expired in 2000.

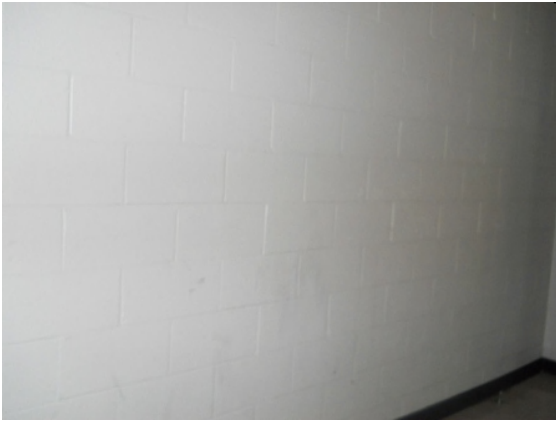
System: C3010 - Wall Finishes

Analysis: The system age is either beyond expected life or does not meet its intended performance under the Guidelines. The system may be in service and functioning but it is recommended to be replaced due to probable increased condition budget needs, the potential failure of its components, or in order to meet the performance Guidelines for this system. The system was installed in 2002. It has a 10-year service life. However, in the assessment, it was found to be currently deficient.

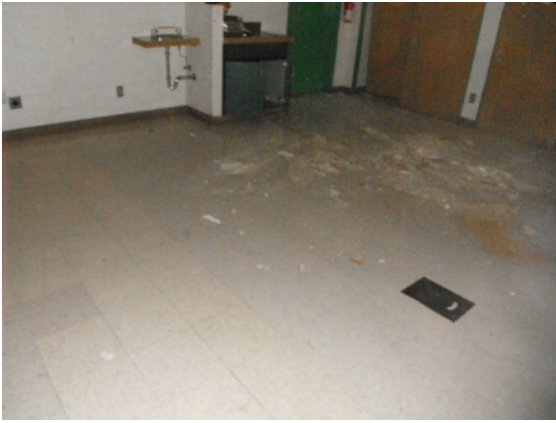
System: C3020410 - VCT

Analysis: The system age is either beyond expected life or does not meet its intended performance under the Guidelines. The system may be in service and functioning but it is recommended to be replaced due to probable increased condition budget needs, the potential failure of its components, or in order to meet the performance Guidelines for this system. The system was installed in 1998. It has a 10-year service life. However, in the assessment, it was found to be currently deficient.

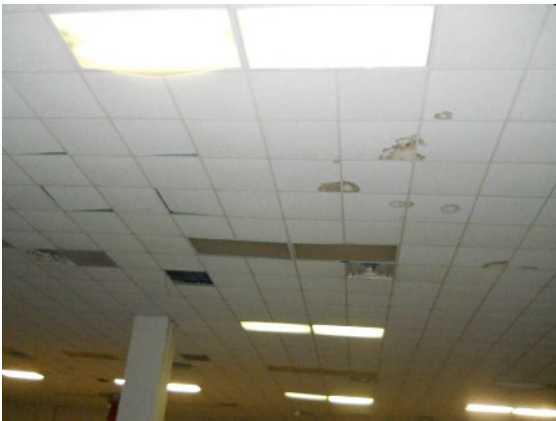
System: C3030 - Ceiling Finishes

Analysis: The system age is either beyond expected life or does not meet its intended performance under the Guidelines. The system may be in service and functioning but it is recommended to be replaced due to probable increased condition budget needs, the potential failure of its components, or in order to meet the performance Guidelines for this system. The system was installed in 1992. It has a 20-year service life. However, in the assessment, it was found to be currently deficient.

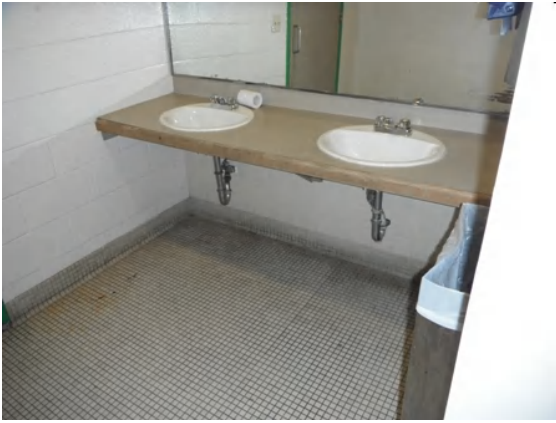
System: D2010 - Plumbing Fixtures

Analysis: The system age is either beyond expected life or does not meet its intended performance under the Guidelines. The system may be in service and functioning but it is recommended to be replaced due to probable increased condition budget needs, the potential failure of its components, or in order to meet the performance Guidelines for this system. The system was installed in 1980. It has a 30-year service life which expired in 2010.

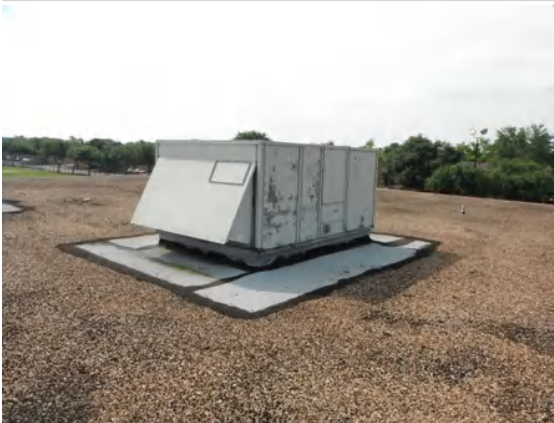
System: D3050 - Terminal & Package Units

Analysis: The system age is either beyond expected life or does not meet its intended performance under the Guidelines. The system may be in service and functioning but it is recommended to be replaced due to probable increased condition budget needs, the potential failure of its components, or in order to meet the performance Guidelines for this system. The system was installed in 1980. It has a 15-year service life which expired in 1995.

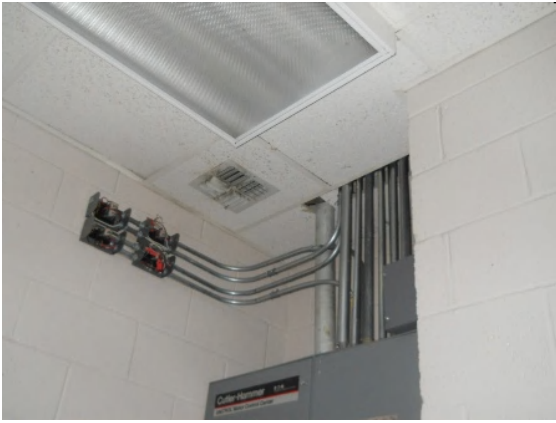
System: D3060 - Controls & Instrumentation

Analysis: The system age is either beyond expected life or does not meet its intended performance under the Guidelines. The system may be in service and functioning but it is recommended to be replaced due to probable increased condition budget needs, the potential failure of its components, or in order to meet the performance Guidelines for this system. The system was installed in 1980. It has a 15-year service life which expired in 1995.

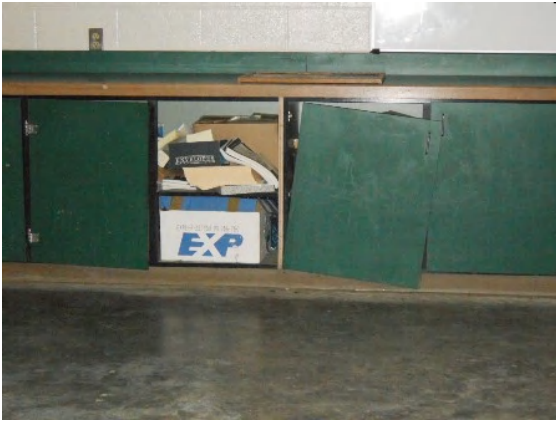
System: E2010 - Fixed Furnishings

Analysis: The system age is either beyond expected life or does not meet its intended performance under the Guidelines. The system may be in service and functioning but it is recommended to be replaced due to probable increased condition budget needs, the potential failure of its components, or in order to meet the performance Guidelines for this system. The system was installed in 1980. It has a 20-year service life which expired in 2000.

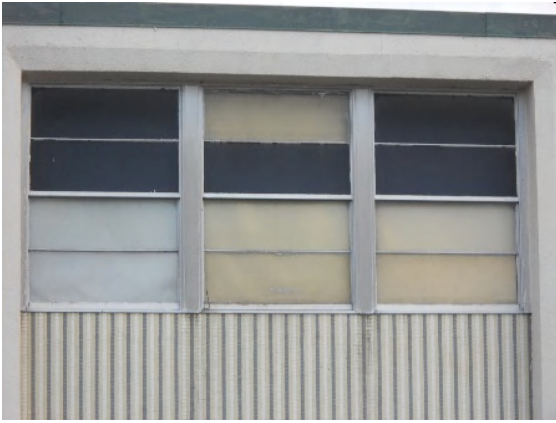
System: B2020 - Exterior Windows

Analysis: The system age is either beyond expected life or does not meet its intended performance under the Guidelines. The system may be in service and functioning but it is recommended to be replaced due to probable increased condition budget needs, the potential failure of its components, or in order to meet the performance Guidelines for this system. The system was installed in 1959. It has a 30-year service life which expired in 1989.

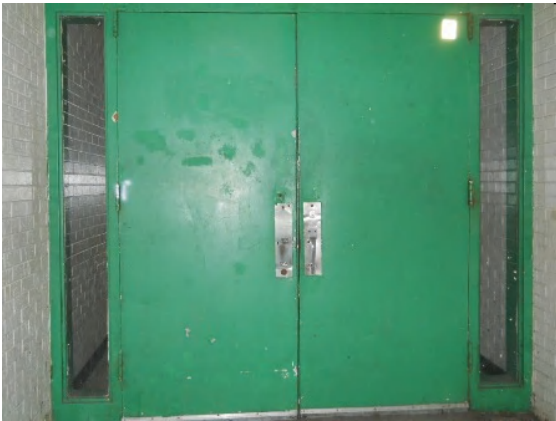
System: B2030 - Exterior Doors

Analysis: The system age is either beyond expected life or does not meet its intended performance under the Guidelines. The system may be in service and functioning but it is recommended to be replaced due to probable increased condition budget needs, the potential failure of its components, or in order to meet the performance Guidelines for this system. The system was installed in 1980. It has a 30-year service life which expired in 2010.

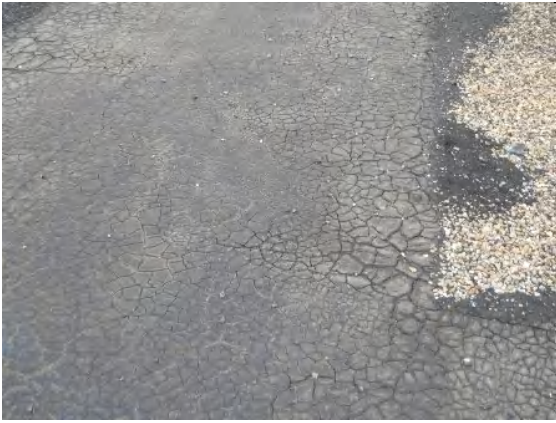
System: B3010105 - Built-Up

Analysis: The system age is either beyond expected life or does not meet its intended performance under the Guidelines. The system may be in service and functioning but it is recommended to be replaced due to probable increased condition budget needs, the potential failure of its components, or in order to meet the performance Guidelines for this system. The system was installed in 1980. It has a 25-year service life which expired in 2005.

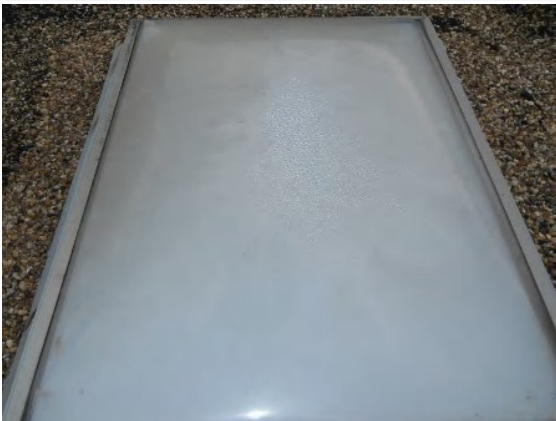
System: B3020 - Roof Openings

Analysis: The system age is either beyond expected life or does not meet its intended performance under the Guidelines. The system may be in service and functioning but it is recommended to be replaced due to probable increased condition budget needs, the potential failure of its components, or in order to meet the performance Guidelines for this system. The system was installed in 1980. It has a 30-year service life which expired in 2010.

Recommendation: The system should be replaced.

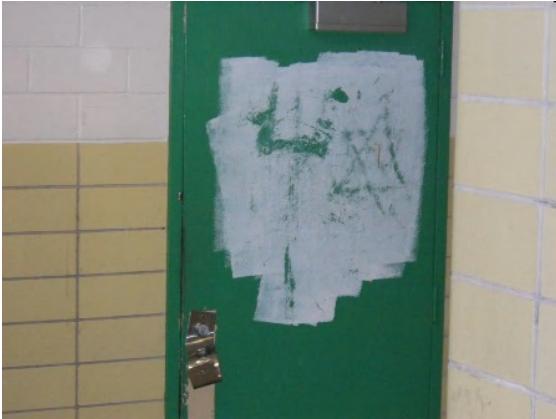
System: C1020 - Interior Doors

Analysis: The system age is either beyond expected life or does not meet its intended performance under the Guidelines. The system may be in service and functioning but it is recommended to be replaced due to probable increased condition budget needs, the potential failure of its components, or in order to meet the performance Guidelines for this system. The system was installed in 1970. It has a 40-year service life which expired in 2010.

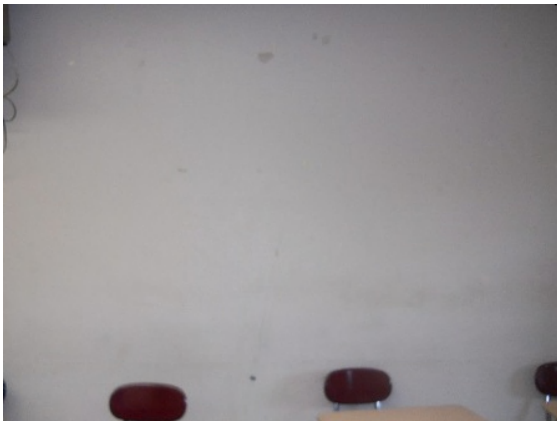
System: C3010 - Wall Finishes

Analysis: The system age is either beyond expected life or does not meet its intended performance under the Guidelines. The system may be in service and functioning but it is recommended to be replaced due to probable increased condition budget needs, the potential failure of its components, or in order to meet the performance Guidelines for this system. The system was installed in 2002. It has a 10-year service life. However, in the assessment, it was found to be currently deficient.

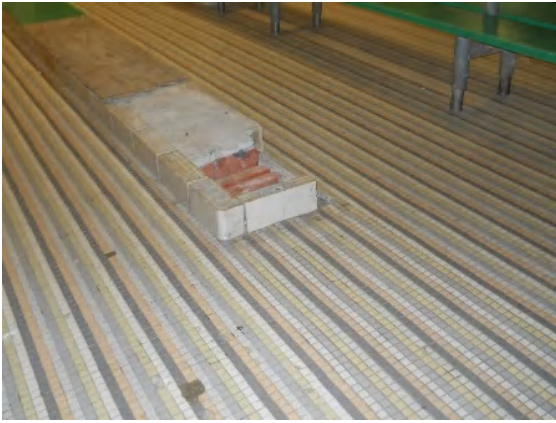
System: C3020210 - Ceramic Tile

Analysis: The system age is either beyond expected life or does not meet its intended performance under the Guidelines. The system may be in service and functioning but it is recommended to be replaced due to probable increased condition budget needs, the potential failure of its components, or in order to meet the performance Guidelines for this system. The system was installed in 1959. It has a 30-year service life which expired in 1989.

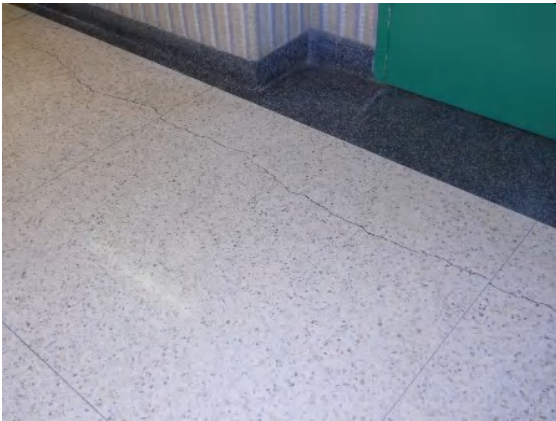
System: C3020210 - Terrazzo

Analysis: The system age is either beyond expected life or does not meet its intended performance under the Guidelines. The system may be in service and functioning but it is recommended to be replaced due to probable increased condition budget needs, the potential failure of its components, or in order to meet the performance Guidelines for this system. The system was installed in 1959. It has a 50-year service life which expired in 2009.

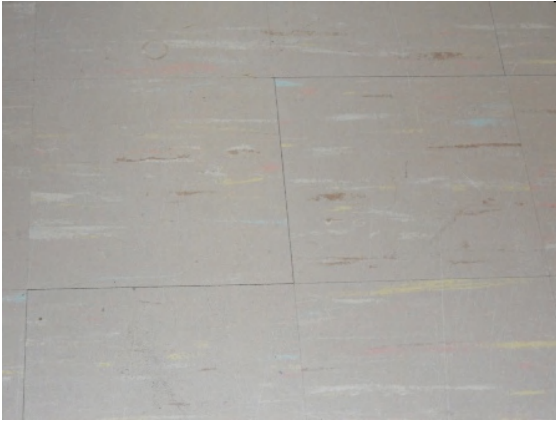
System: C3020410 - VCT

Analysis: The system age is either beyond expected life or does not meet its intended performance under the Guidelines. The system may be in service and functioning but it is recommended to be replaced due to probable increased condition budget needs, the potential failure of its components, or in order to meet the performance Guidelines for this system. The system was installed in 1980. It has a 15-year service life which expired in 1995.

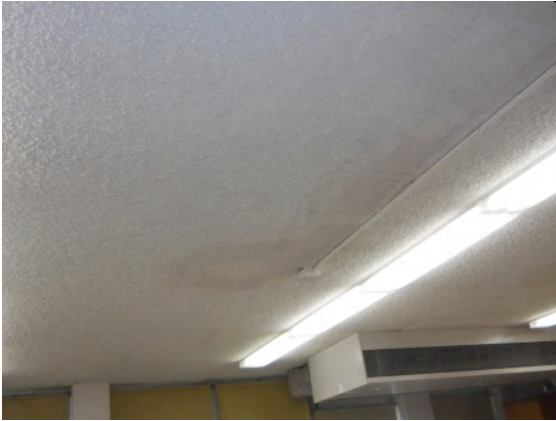
System: C3030 - Ceiling Finishes

Analysis: The system age is either beyond expected life or does not meet its intended performance under the Guidelines. The system may be in service and functioning but it is recommended to be replaced due to probable increased condition budget needs, the potential failure of its components, or in order to meet the performance Guidelines for this system. The system was installed in 1997. It has a 15-year service life. However, in the assessment, it was found to be currently deficient.

Recommendation: The system should be replaced.

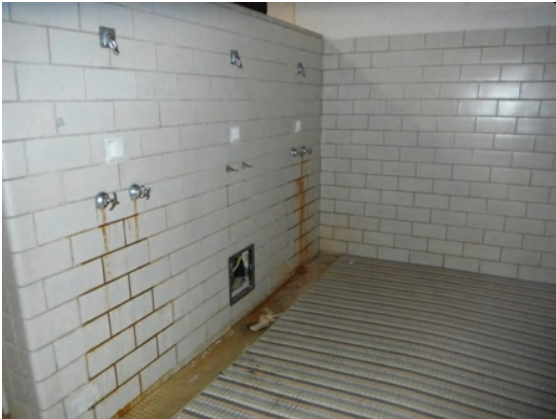
System: D2020 - Domestic Water Distribution

Analysis: The system age is either beyond expected life or does not meet its intended performance under the Guidelines. The system may be in service and functioning but it is recommended to be replaced due to probable increased condition budget needs, the potential failure of its components, or in order to meet the performance Guidelines for this system. The system was installed in 1959. It has a 30-year service life which expired in 1989.
