School Assessment Report

Type: High Schools
School: Yates High School
Date: Jul 16, 2012

Final

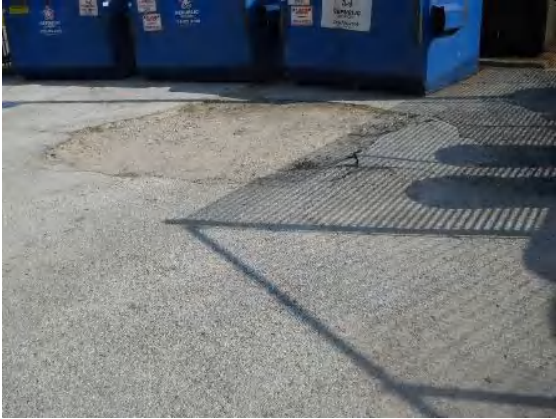
System: G2010 - Roadways

Analysis: The system age is either beyond expected life or does not meet its intended performance under the Guidelines. The system may be in service and functioning but it is recommended to be replaced due to probable increased condition budget needs, the potential failure of its components, or in order to meet the performance Guidelines for this system. The system was installed in 1986. It has a 25-year service life which expired in 2011.

Notes: The driveways are beyond useful life and require replacement.

Recommendation: The system should be replaced.

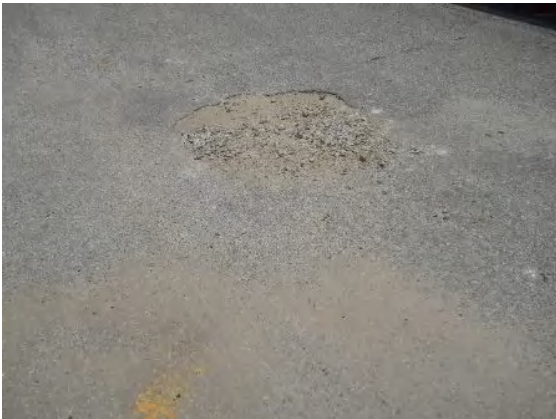
System: G2020 - Parking Lots

Analysis: The system age is either beyond expected life or does not meet its intended performance under the Guidelines. The system may be in service and functioning but it is recommended to be replaced due to probable increased condition budget needs, the potential failure of its components, or in order to meet the performance Guidelines for this system. The system was installed in 1986. It has a 25-year service life which expired in 2011.

Notes: The parking lots are beyond useful life and require replacement.

Recommendation: The system should be replaced.

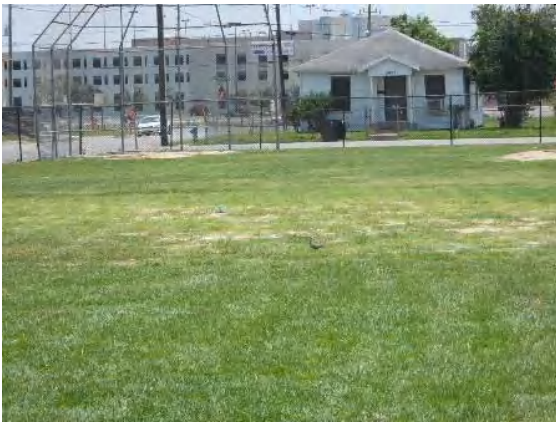
System: G2040 - Baseball Field

Analysis: The system age is either beyond expected life or does not meet its intended performance under the Guidelines. The system may be in service and functioning but it is recommended to be replaced due to probable increased condition budget needs, the potential failure of its components, or in order to meet the performance Guidelines for this system. The system was installed in 1958. It has a 30-year service life which expired in 1988.

Recommendation: The system should be replaced.

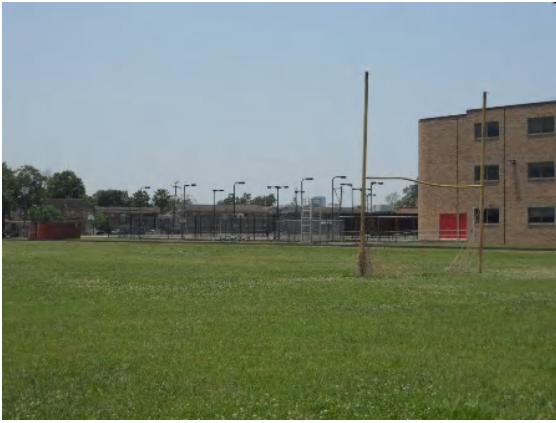
System: G2040 - Football Field Natural Turf

Analysis: The system age is either beyond expected life or does not meet its intended performance under the Guidelines. The system may be in service and functioning but it is recommended to be replaced due to probable increased condition budget needs, the potential failure of its components, or in order to meet the performance Guidelines for this system. The system was installed in 1958. It has a 10-year service life which expired in 1968.

Recommendation: The system should be replaced.

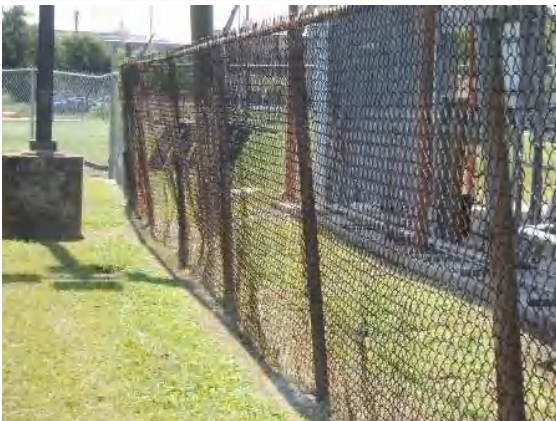
System: G2040 - Site Development

Analysis: The system age is either beyond expected life or does not meet its intended performance under the Guidelines. The system may be in service and functioning but it is recommended to be replaced due to probable increased condition budget needs, the potential failure of its components, or in order to meet the performance Guidelines for this system. The system was installed in 1958. It has a 30-year service life which expired in 1988.

Notes: The fencing inside the perimeter are beyond useful life and require replacement. The grounds have random holes.

Recommendation: The system should be replaced.

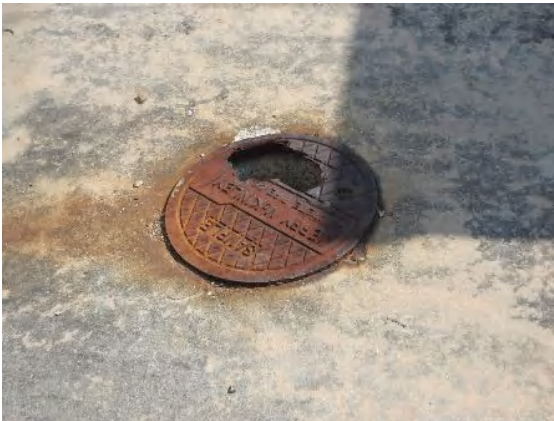
System: G3020 - Sanitary Sewer

Analysis: The system age is either beyond expected life or does not meet its intended performance under the Guidelines. The system may be in service and functioning but it is recommended to be replaced due to probable increased condition budget needs, the potential failure of its components, or in order to meet the performance Guidelines for this system. The system was installed in 1958. It has a 50-year service life which expired in 2008.

Notes: The sanitary sewer system is beyond useful life and requires replacement.

Recommendation: The system should be replaced.

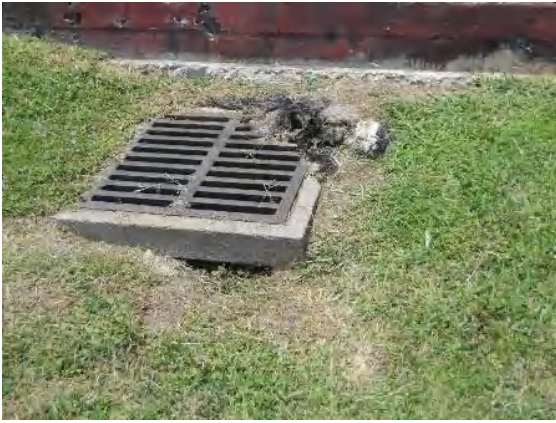
System: G3030 - Storm Sewer

Analysis: The system age is either beyond expected life or does not meet its intended performance under the Guidelines. The system may be in service and functioning but it is recommended to be replaced due to probable increased condition budget needs, the potential failure of its components, or in order to meet the performance Guidelines for this system. The system was installed in 1958. It has a 50-year service life which expired in 2008.

Notes: The storm sewer system is beyond useful life and requires replacement.

Recommendation: The system should be replaced.

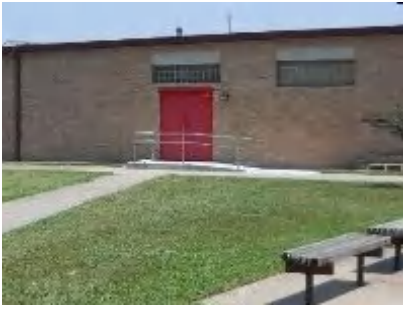
Location: Boys Weight Room
Distress: Beyond Expected Life
Category: Deferred Maintenance
Priority: 3 - Short Term Conditions (2-3 Years)
Notes: The exterior window system has exceeded its useful life and requires replacement.
Correction: Renew System
Qty: 1-Ea.
Condition Budget: \$78,463

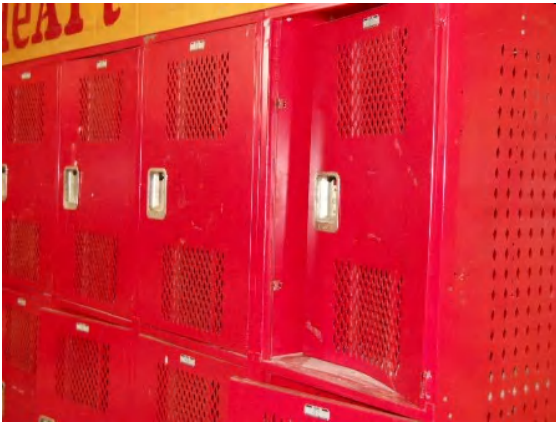
System: C1030 - Fittings

Analysis: The system age is either beyond expected life or does not meet its intended performance under the Guidelines. The system may be in service and functioning but it is recommended to be replaced due to probable increased condition budget needs, the potential failure of its components, or in order to meet the performance Guidelines for this system. The system was installed in 1986. It has a 20-year service life which expired in 2006.

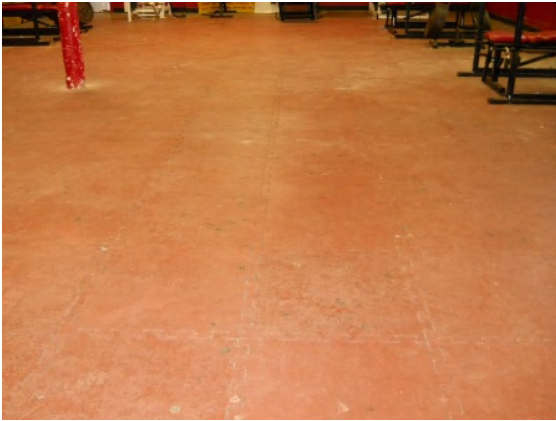
System: C3020410 - Rubber/Resilient

Analysis: The system age is either beyond expected life or does not meet its intended performance under the Guidelines. The system may be in service and functioning but it is recommended to be replaced due to probable increased condition budget needs, the potential failure of its components, or in order to meet the performance Guidelines for this system. The system was installed in 1986. It has a 15-year service life which expired in 2001.

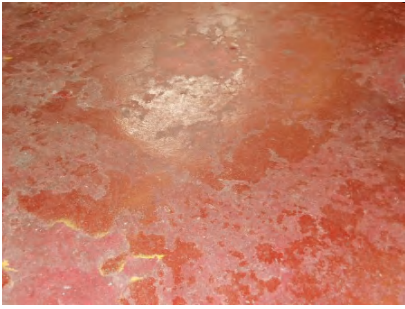
Location: Boys Weight Room
Distress: Beyond Expected Life
Category: Deferred Maintenance
Priority: 3 - Short Term Conditions (2-3 Years)
Notes: The sealant on the concrete is failing and the concrete has been exposed.
Correction: Renew System
Qty: 1-Ea.
Condition Budget: \$9,002

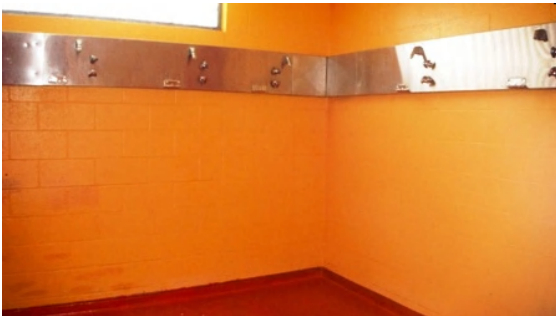
System: D2010 - Plumbing Fixtures

Analysis: The system age is either beyond expected life or does not meet its intended performance under the Guidelines. The system may be in service and functioning but it is recommended to be replaced due to probable increased condition budget needs, the potential failure of its components, or in order to meet the performance Guidelines for this system. The system was installed in 1986. It has a 30-year service life. However, in the assessment, it was found to be currently deficient.

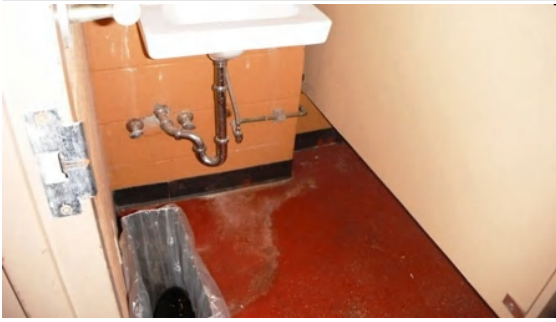
System: D2020 - Domestic Water Distribution

Analysis: The system age is either beyond expected life or does not meet its intended performance under the Guidelines. The system may be in service and functioning but it is recommended to be replaced due to probable increased condition budget needs, the potential failure of its components, or in order to meet the performance Guidelines for this system. The system was installed in 1958. It has a 30-year service life which expired in 1988.

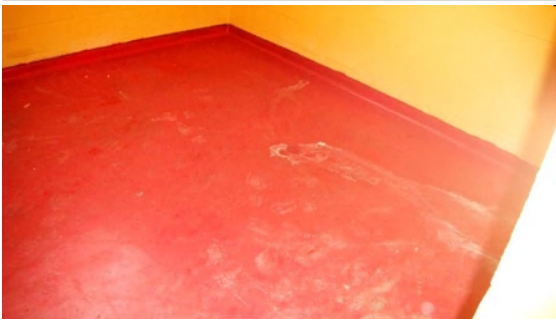
System: D2030 - Sanitary Waste

Analysis: The system age is either beyond expected life or does not meet its intended performance under the Guidelines. The system may be in service and functioning but it is recommended to be replaced due to probable increased condition budget needs, the potential failure of its components, or in order to meet the performance Guidelines for this system. The system was installed in 1958. It has a 30-year service life which expired in 1988.

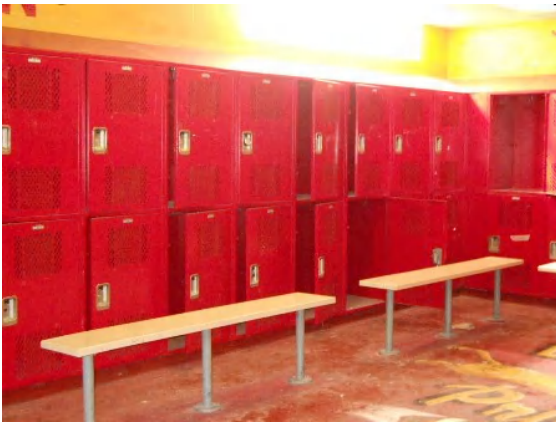
System: E2010 - Fixed Furnishings

Analysis: The system age is either beyond expected life or does not meet its intended performance under the Guidelines. The system may be in service and functioning but it is recommended to be replaced due to probable increased condition budget needs, the potential failure of its components, or in order to meet the performance Guidelines for this system. The system was installed in 1958. It has a 20-year service life which expired in 1978.

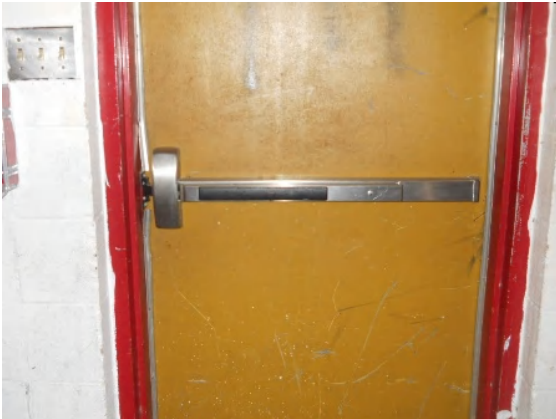
System: B2030 - Exterior Doors

Analysis: The system age is either beyond expected life or does not meet its intended performance under the Guidelines. The system may be in service and functioning but it is recommended to be replaced due to probable increased condition budget needs, the potential failure of its components, or in order to meet the performance Guidelines for this system. The system was installed in 1958. It has a 30-year service life which expired in 1988.

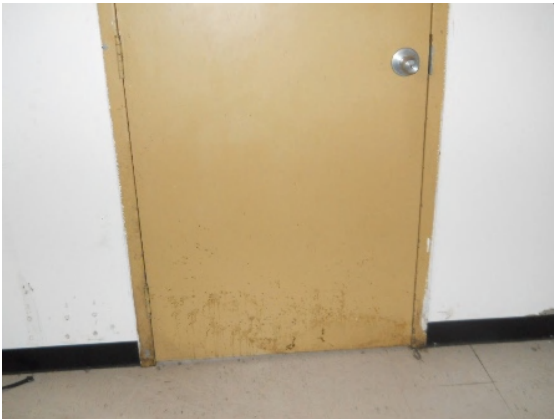
System: C1020 - Interior Doors

Analysis: The system age is either beyond expected life or does not meet its intended performance under the Guidelines. The system may be in service and functioning but it is recommended to be replaced due to probable increased condition budget needs, the potential failure of its components, or in order to meet the performance Guidelines for this system. The system was installed in 1986. It has a 40-year service life. However, in the assessment, it was found to be currently deficient.

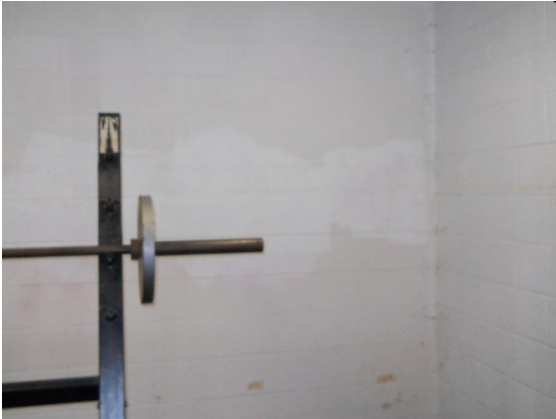
System: C3010 - Wall Finishes

Analysis: The system age is either beyond expected life or does not meet its intended performance under the Guidelines. The system may be in service and functioning but it is recommended to be replaced due to probable increased condition budget needs, the potential failure of its components, or in order to meet the performance Guidelines for this system. The system was installed in 1986. It has a 10-year service life which expired in 1996.

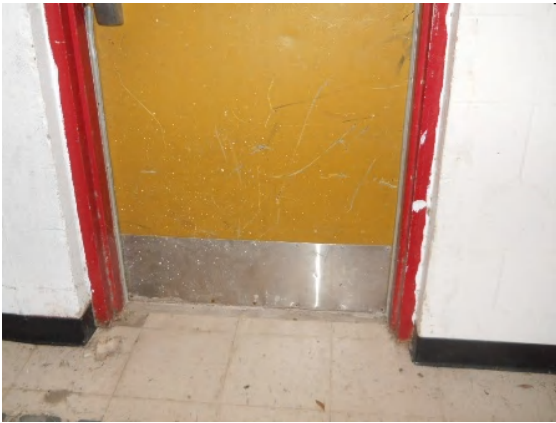
System: C3020410 - VCT

Analysis: The system age is either beyond expected life or does not meet its intended performance under the Guidelines. The system may be in service and functioning but it is recommended to be replaced due to probable increased condition budget needs, the potential failure of its components, or in order to meet the performance Guidelines for this system. The system was installed in 1986. It has a 15-year service life which expired in 2001.

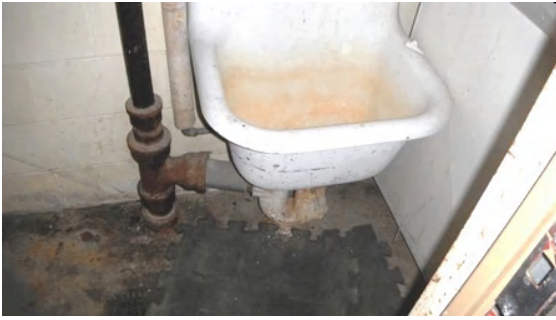
System: D2010 - Plumbing Fixtures

Analysis: The system age is either beyond expected life or does not meet its intended performance under the Guidelines. The system may be in service and functioning but it is recommended to be replaced due to probable increased condition budget needs, the potential failure of its components, or in order to meet the performance Guidelines for this system. The system was installed in 1958. It has a 30-year service life which expired in 1988.

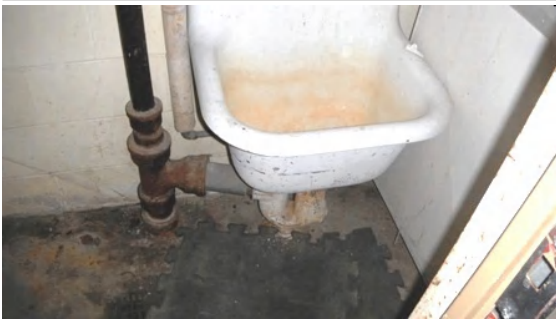
System: D2020 - Domestic Water Distribution

Analysis: The system age is either beyond expected life or does not meet its intended performance under the Guidelines. The system may be in service and functioning but it is recommended to be replaced due to probable increased condition budget needs, the potential failure of its components, or in order to meet the performance Guidelines for this system. The system was installed in 1958. It has a 30-year service life which expired in 1988.

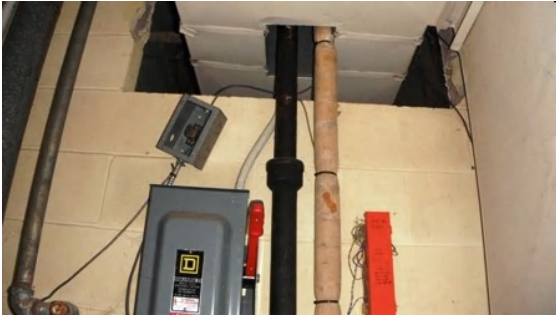
System: D2040 - Rain Water Drainage

Analysis: The system age is either beyond expected life or does not meet its intended performance under the Guidelines. The system may be in service and functioning but it is recommended to be replaced due to probable increased condition budget needs, the potential failure of its components, or in order to meet the performance Guidelines for this system. The system was installed in 1958. It has a 30-year service life which expired in 1988.

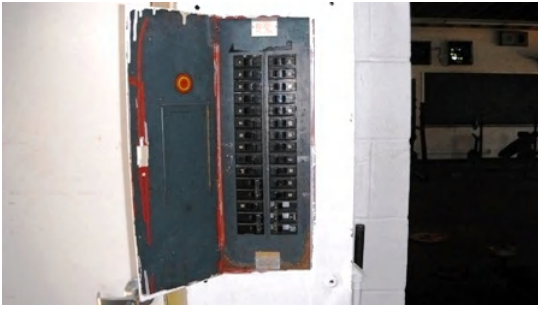
Location: Girls Weight Room
 Distress: Beyond Expected Life
 Category: Deferred Maintenance
 Priority: 3 - Short Term Conditions (2-3 Years)
 Notes: The original service and distribution system is aged and should be replaced.
 Correction: Renew System
 Qty: 1-Ea.
 Condition Budget: \$13,154

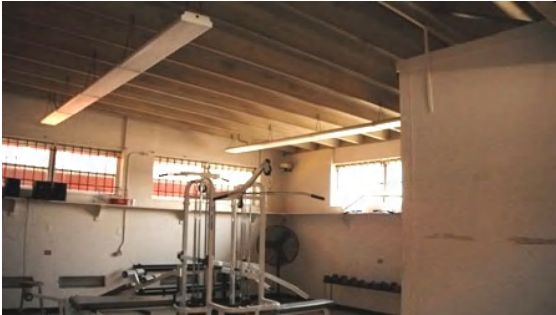
System: D5020 - Lighting and Branch Wiring

Analysis: The system age is either beyond expected life or does not meet its intended performance under the Guidelines. The system may be in service and functioning but it is recommended to be replaced due to probable increased condition budget needs, the potential failure of its components, or in order to meet the performance Guidelines for this system. The system was installed in 1986. It has a 30-year service life. However, in the assessment, it was found to be currently deficient.

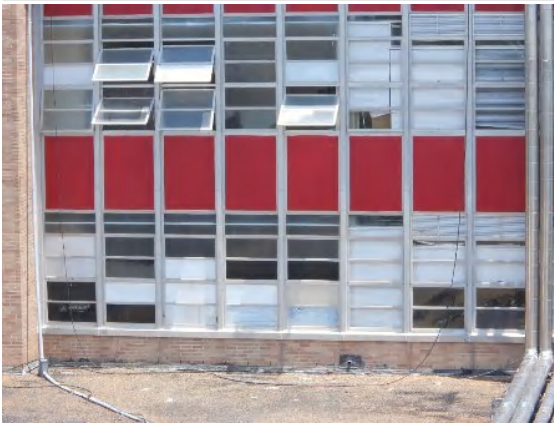
System: B2020 - Exterior Windows

Analysis: The system age is either beyond expected life or does not meet its intended performance under the Guidelines. The system may be in service and functioning but it is recommended to be replaced due to probable increased condition budget needs, the potential failure of its components, or in order to meet the performance Guidelines for this system. The system was installed in 1958. It has a 30-year service life which expired in 1988.

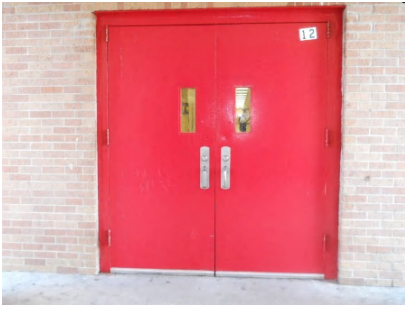
Location: Main
Distress: Beyond Expected Life
Category: Deferred Maintenance
Priority: 3 - Short Term Conditions (2-3 Years)
Notes: The exterior doors are showing signs of wear, beyond useful life and require replacement.
Correction: Renew System
Qty: 1-Ea.
Condition Budget: \$219,684
