School Assessment Report

School: Garden Oaks Elementary School

Date: Jul 16, 2012

Garden Oaks Elementary School campus is located at 901 Sue Barnett Drive, Houston, TX, and consists of 4 main school buildings. The original campus was constructed in 1979 and multi-purpose building was added to the main school building in 1941 and renovations in 2005. Ancillary buildings on campus include, student dining, classroom, multi-purpose building and T-Buildings. In addition to the buildings, the campus contains covered walkways and playground equipment. This report contains condition and adequacy data collected during the 2012 Facility Condition Assessment (FCA). The detailed condition and deficiency statements are contained in this report for each building and other facilities on the campus.

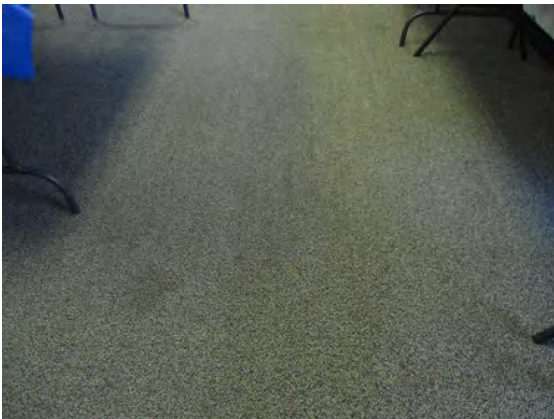
System: C3020410 - Carpet

Analysis: The system age is either beyond expected life or does not meet its intended performance under the Guidelines. The system may be in service and functioning but it is recommended to be replaced due to probable increased condition budget needs, the potential failure of its components, or in order to meet the performance Guidelines for this system. The system was installed in 2005. It has a 7-year service life. However, in the assessment, it was found to be currently deficient.

Priority: 3 - Short Term Conditions (2-3 Years)

Notes: The carpet is showing signs of wear, it is stained at some locations, and carpet is beyond expected life and needs to be replaced

Recommendation: The system should be replaced.

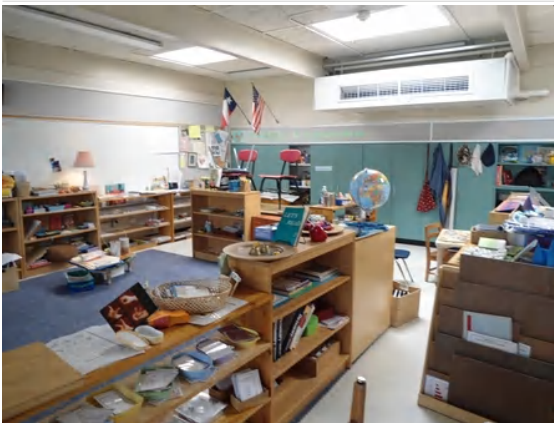
System: C3020410 - VCT

Analysis: The system age is either beyond expected life or does not meet its intended performance under the Guidelines. The system may be in service and functioning but it is recommended to be replaced due to probable increased condition budget needs, the potential failure of its components, or in order to meet the performance Guidelines for this system. The system was installed in 2005. It has a 15-year service life which expired in 2011.

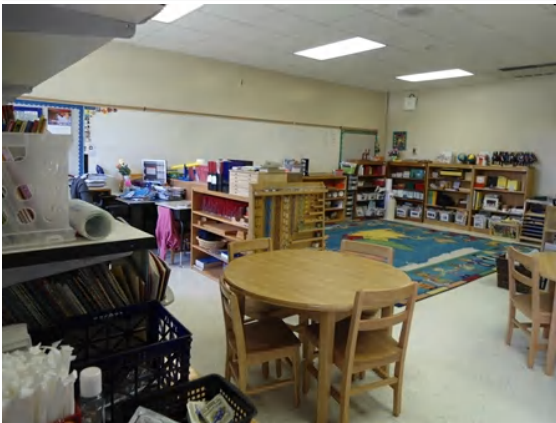
System: C3020410 - VCT

Analysis: The system age is either beyond expected life or does not meet its intended performance under the Guidelines. The system may be in service and functioning but it is recommended to be replaced due to probable increased condition budget needs, the potential failure of its components, or in order to meet the performance Guidelines for this system. The system was installed in 1979. It has a 15-year service life which expired in 1994.
