# School Assessment Report

School: Wharton Dual Language Academy

Date: Jul 16, 2012

## Executive Summary

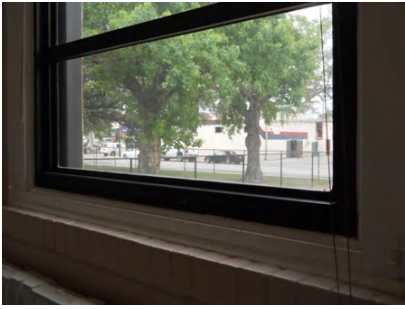
**Analysis:** The system age is either beyond expected life or does not meet its intended performance under the Guidelines. The system may be in service and functioning but it is recommended to be replaced due to probable increased condition budget needs, the potential failure of its components, or in order to meet the performance Guidelines for this system. The system was installed in 1929. It has a 30-year service life which expired in 1959.

Location: Main  
Distress: Beyond Expected Life  
Category: Deferred Maintenance  
Priority: 3 - Short Term Conditions (2-3 Years)  
Notes: System is beyond useful life and requires replacement.  
Correction: Renew System  
Qty: 1-Ea.  
Condition Budget: \$248,946

**Recommendation:** The system should be replaced.

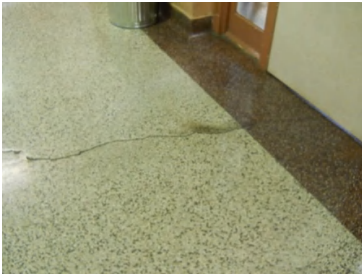
Location: Main  
Distress: Beyond Expected Life  
Category: Deferred Maintenance  
Priority: 3 - Short Term Conditions (2-3 Years)  
Notes: The terrazzo flooring is cracked and uneven.  
Correction: Renew System  
Qty: 1-Ea.  
Condition Budget: \$88,450

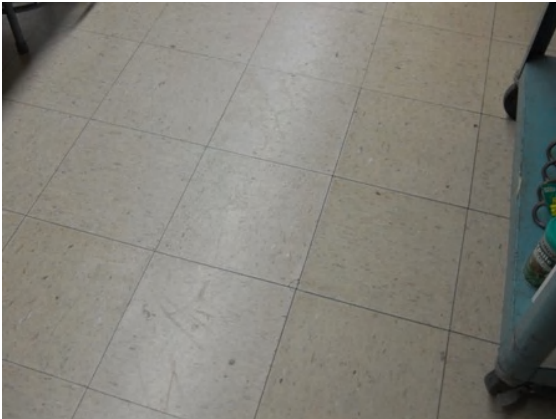
**System:** C3020410 - VCT Floor Covering

**Analysis:** The system age is either beyond expected life or does not meet its intended performance under the Guidelines. The system may be in service and functioning but it is recommended to be replaced due to probable increased condition budget needs, the potential failure of its components, or in order to meet the performance Guidelines for this system. The system was installed in 1980. It has a 15-year service life which expired in 1995.

Location: Main  
Distress: Beyond Expected Life  
Category: Deferred Maintenance  
Priority: 3 - Short Term Conditions (2-3 Years)  
Notes: System is beyond useful life and requires replacement. Cracked, shifting, buckling throughout.  
Correction: Renew System  
Qty: 1-Ea.  
Condition Budget: \$99,707

**Recommendation:** The system should be replaced.

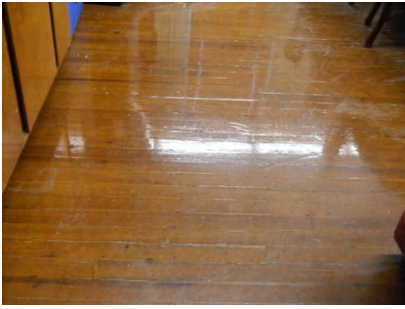
**Analysis:** The system age is either beyond expected life or does not meet its intended performance under the Guidelines. The system may be in service and functioning but it is recommended to be replaced due to probable increased condition budget needs, the potential failure of its components, or in order to meet the performance Guidelines for this system. The system was installed in 1929. It has a 30-year service life which expired in 1959.

Location: Main  
Distress: Beyond Expected Life  
Category: Deferred Maintenance  
Priority: 3 - Short Term Conditions (2-3 Years)  
Notes: System is beyond useful life and requires replacement.  
Correction: Renew System  
Qty: 1-Ea.  
Condition Budget: \$98,742

**Recommendation:** The system should be replaced.

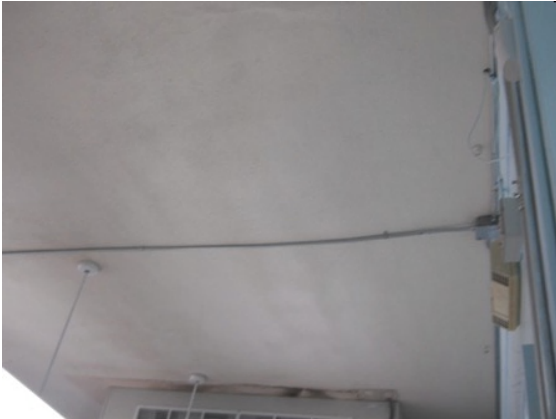
**System:** C3030 - Ceiling Finishes

**Analysis:** The system age is either beyond expected life or does not meet its intended performance under the Guidelines. The system may be in service and functioning but it is recommended to be replaced due to probable increased condition budget needs, the potential failure of its components, or in order to meet the performance Guidelines for this system. The system was installed in 1980. It has a 20-year service life which expired in 2000.

Location: Main  
Distress: Beyond Expected Life  
Category: Deferred Maintenance  
Priority: 3 - Short Term Conditions (2-3 Years)  
Notes: Ceiling is cracked, rippled, or peeling throughout the facility.  
Correction: Renew System  
Qty: 1-Ea.  
Condition Budget: \$233,829

**Recommendation:** The system should be replaced.

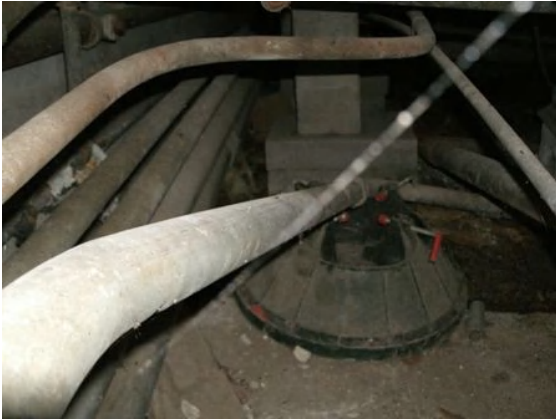
**System:** D2030 - Sanitary Waste

Analysis: The system age is either beyond expected life or does not meet its intended performance under the Guidelines. The system may be in service and functioning but it is recommended to be replaced due to probable increased condition budget needs, the potential failure of its components, or in order to meet the performance Guidelines for this system. The system was installed in 1929. It has a 30-year service life which expired in 1959.

Location: Main  
Distress: Failing  
Category: Deferred Maintenance  
Priority: 3 - Short Term Conditions (2-3 Years)  
Notes: The sanitary sewer system is failing, has foul odors in sections of the building, appears to have a failing lift station in the crawl space, and should be replaced.

Recommendation: The system should be replaced.

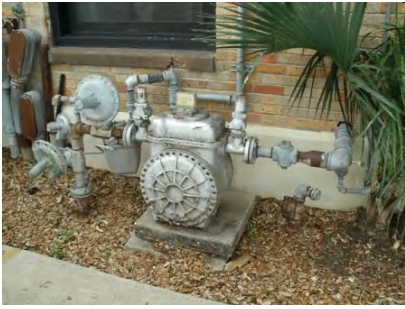
Analysis: The system age is either beyond expected life or does not meet its intended performance under the Guidelines. The system may be in service and functioning but it is recommended to be replaced due to probable increased condition budget needs, the potential failure of its components, or in order to meet the performance Guidelines for this system. The system was installed in 1985. It has a 20-year service life which expired in 2005.

Location: Main  
Distress: Beyond Expected Life  
Category: Deferred Maintenance  
Priority: 3 - Short Term Conditions (2-3 Years)  
Notes: The natural gas service is beyond it's expected useful life and should be replaced.  
Correction: Renew System  
Qty: 1-Ea.  
Condition Budget: \$17,368

Recommendation: The system should be replaced.
