School Assessment Report

Type: High Schools
School: Sterling High School
Date: Jul 16, 2012

School Name: Sterling High School

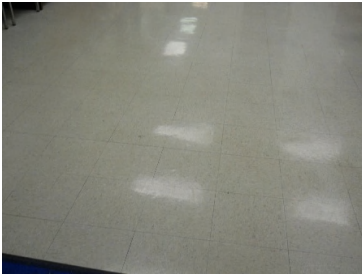
Location: Building A
Distress: Beyond Expected Life
Category: Deferred Maintenance
Priority: 3 - Short Term Conditions (2-3 Years)
Notes: VCT System beyond useful life. Replace
Correction: Renew System
Qty: 1-Ea.
Condition Budget: \$304,230

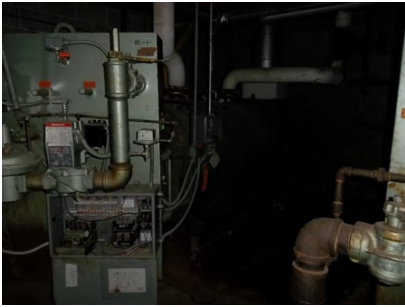
Location: Building A
Distress: Beyond Expected Life
Category: Deferred Maintenance
Priority: 3 - Short Term Conditions (2-3 Years)
Notes: Heat Generating System beyond useful life.
Replace

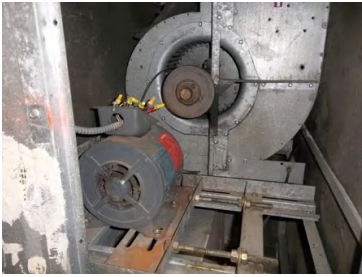
Location: Building A
Distress: Beyond Expected Life
Category: Deferred Maintenance
Priority: 3 - Short Term Conditions (2-3 Years)
Notes: Distribution Systems beyond useful life. Replace
Correction: Renew System
Qty: 1-Ea.
Condition Budget: \$1,005,488

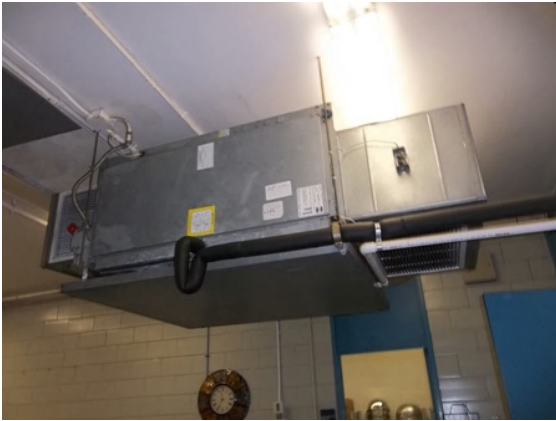
System: D3050 - Terminal & Package Units

Analysis: The system age is either beyond expected life or does not meet its intended performance under the Guidelines. The system may be in service and functioning but it is recommended to be replaced due to probable increased condition budget needs, the potential failure of its components, or in order to meet the performance Guidelines for this system. The system was installed in 1965. It has a 15-year service life which expired in 1980.

Recommendation: The system should be replaced.

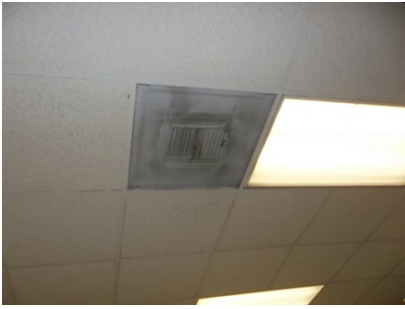
Location: Building A
Distress: Beyond Expected Life
Category: Deferred Maintenance
Priority: 3 - Short Term Conditions (2-3 Years)
Notes: Systems Testing & Balance, Beyond useful life.
Rebalance system after system is renewed
Correction: Renew System
Qty: 1-Ea.
Condition Budget: \$71,653

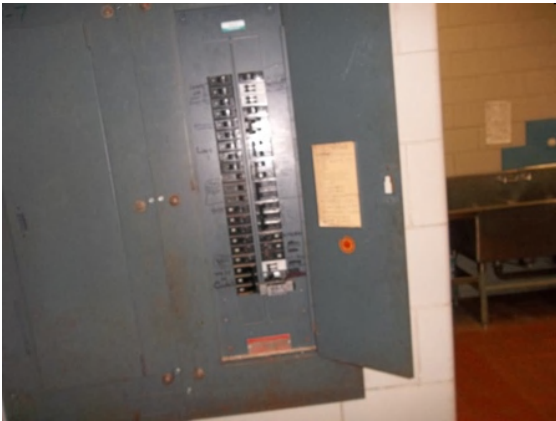
System: D5020 - Lighting and Branch Wiring

Analysis: The system age is either beyond expected life or does not meet its intended performance under the Guidelines. The system may be in service and functioning but it is recommended to be replaced due to probable increased condition budget needs, the potential failure of its components, or in order to meet the performance Guidelines for this system. The system was installed in 1965. It has a 30-year service life which expired in 1995.

Recommendation: The system should be replaced.

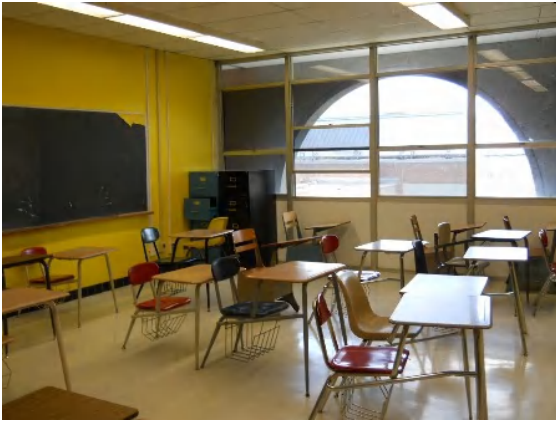
System: B2020 - Exterior Windows

Analysis: The system age is either beyond expected life or does not meet its intended performance under the Guidelines. The system may be in service and functioning but it is recommended to be replaced due to probable increased condition budget needs, the potential failure of its components, or in order to meet the performance Guidelines for this system. The system was installed in 1965. It has a 30-year service life which expired in 1995.

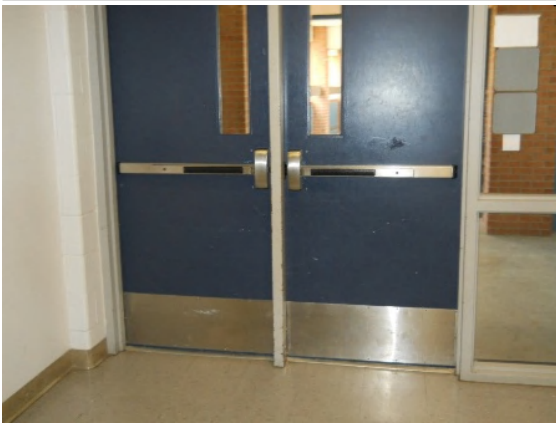
System: B2030 - Exterior Doors

Analysis: The system age is either beyond expected life or does not meet its intended performance under the Guidelines. The system may be in service and functioning but it is recommended to be replaced due to probable increased condition budget needs, the potential failure of its components, or in order to meet the performance Guidelines for this system. The system was installed in 1965. It has a 30-year service life which expired in 1995.

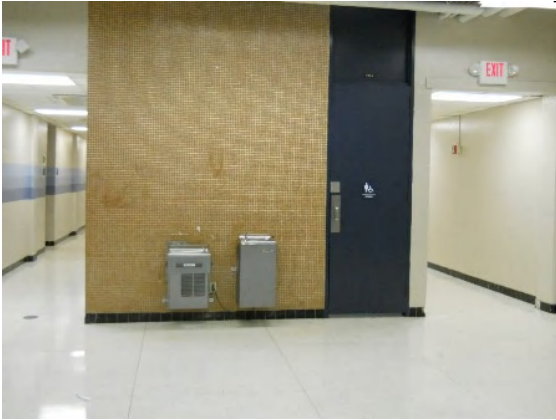
System: C1020 - Interior Doors

Analysis: The system age is either beyond expected life or does not meet its intended performance under the Guidelines. The system may be in service and functioning but it is recommended to be replaced due to probable increased condition budget needs, the potential failure of its components, or in order to meet the performance Guidelines for this system. The system was installed in 1965. It has a 40-year service life which expired in 2005.

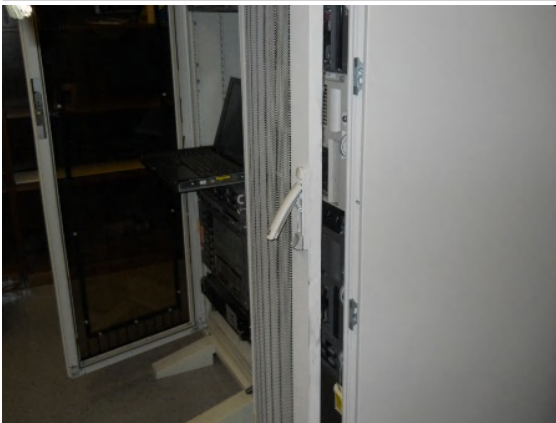
System: C1030 - Fittings

Analysis: The system age is either beyond expected life or does not meet its intended performance under the Guidelines. The system may be in service and functioning but it is recommended to be replaced due to probable increased condition budget needs, the potential failure of its components, or in order to meet the performance Guidelines for this system. The system was installed in 1965. It has a 20-year service life which expired in 1985.

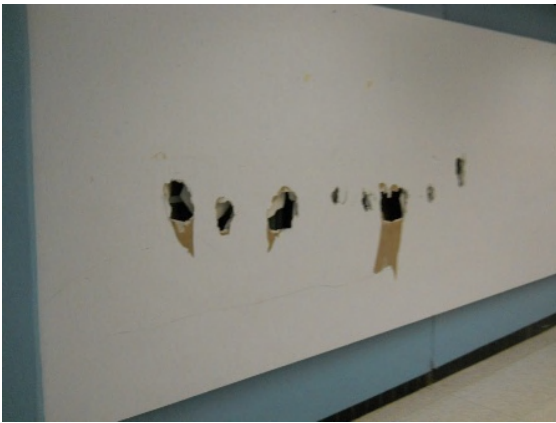
System: C3010 - Wall Finishes

Analysis: The system age is either beyond expected life or does not meet its intended performance under the Guidelines. The system may be in service and functioning but it is recommended to be replaced due to probable increased condition budget needs, the potential failure of its components, or in order to meet the performance Guidelines for this system. The system was installed in 1985. It has a 10-year service life which expired in 1995.

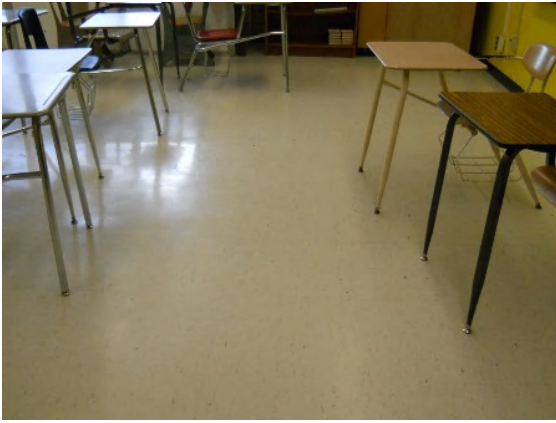
System: C3020410 - VCT

Analysis: The system age is either beyond expected life or does not meet its intended performance under the Guidelines. The system may be in service and functioning but it is recommended to be replaced due to probable increased condition budget needs, the potential failure of its components, or in order to meet the performance Guidelines for this system. The system was installed in 1985. It has a 12-year service life which expired in 1997.

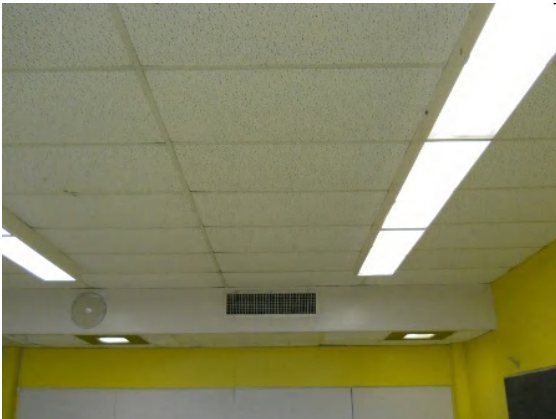
System: C3030 - Ceiling Finishes

Analysis: The system age is either beyond expected life or does not meet its intended performance under the Guidelines. The system may be in service and functioning but it is recommended to be replaced due to probable increased condition budget needs, the potential failure of its components, or in order to meet the performance Guidelines for this system. The system was installed in 1985. It has a 20-year service life which expired in 2005.

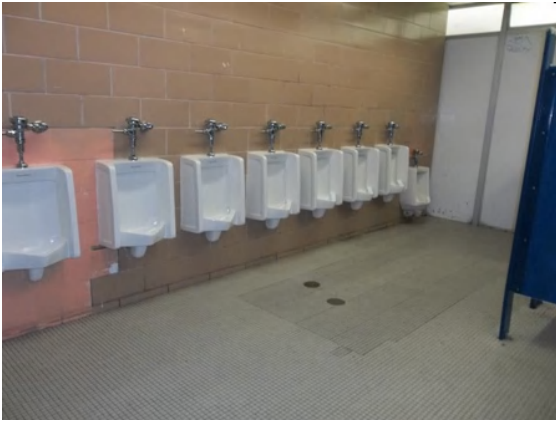
System: D2010 - Plumbing Fixtures

Analysis: The system age is either beyond expected life or does not meet its intended performance under the Guidelines. The system may be in service and functioning but it is recommended to be replaced due to probable increased condition budget needs, the potential failure of its components, or in order to meet the performance Guidelines for this system. The system was installed in 1965. It has a 30-year service life which expired in 1995.

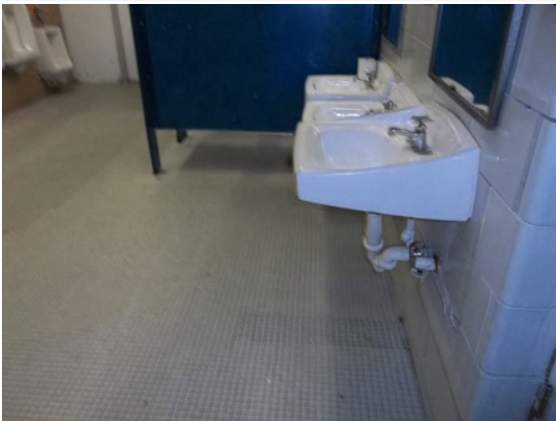
System: D2020 - Domestic Water Distribution

Analysis: The system age is either beyond expected life or does not meet its intended performance under the Guidelines. The system may be in service and functioning but it is recommended to be replaced due to probable increased condition budget needs, the potential failure of its components, or in order to meet the performance Guidelines for this system. The system was installed in 1965. It has a 30-year service life which expired in 1995.

Recommendation: The system should be replaced.

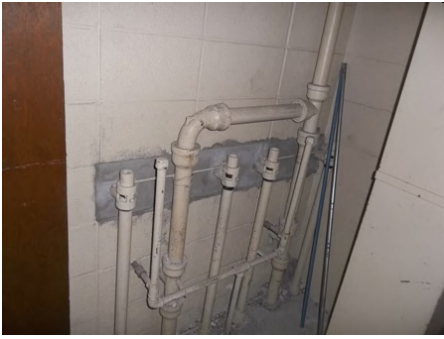
Location: Building B
Distress: Beyond Expected Life
Category: Deferred Maintenance
Priority: 3 - Short Term Conditions (2-3 Years)
Notes: Sanitary Waste System beyond useful life. Replace

Correction: Renew System
Qty: 1-Ea.
Condition Budget: \$225,107

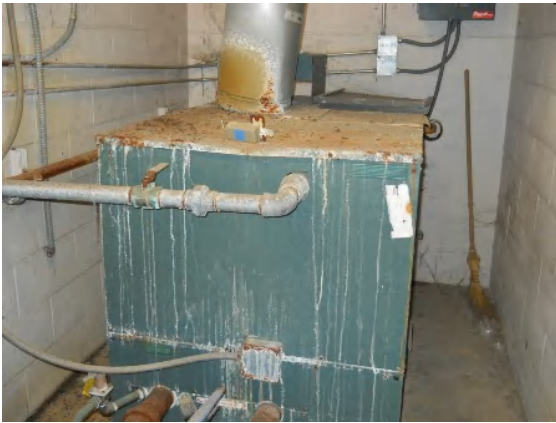
System: D2090 - Other Plumbing Systems-Nat Gas

Analysis: The system age is either beyond expected life or does not meet its intended performance under the Guidelines. The system may be in service and functioning but it is recommended to be replaced due to probable increased condition budget needs, the potential failure of its components, or in order to meet the performance Guidelines for this system. The system was installed in 1965. It has a 20-year service life which expired in 1985.

Recommendation: The system should be replaced.

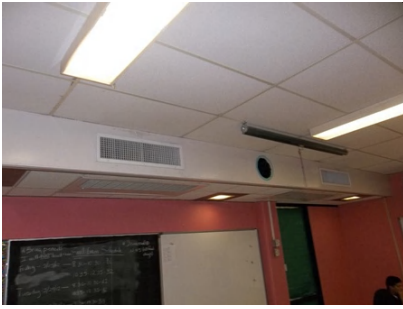
Location: Building B
Distress: Beyond Expected Life
Category: Deferred Maintenance
Priority: 3 - Short Term Conditions (2-3 Years)
Notes: Terminal & Package Units System beyond useful life. Replace
Correction: Renew System
Qty: 1-Ea.
Condition Budget: \$994,861

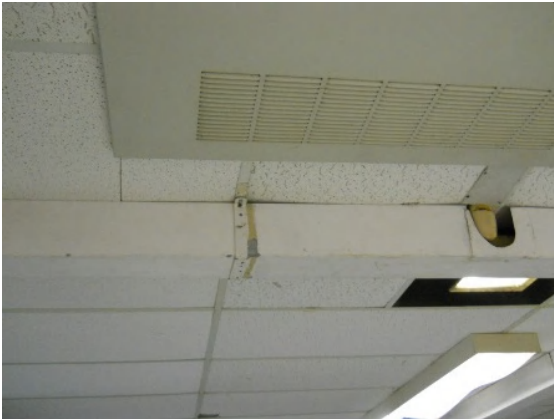
System: D3070 - Systems Testing & Balance

Analysis: The system age is either beyond expected life or does not meet its intended performance under the Guidelines. The system may be in service and functioning but it is recommended to be replaced due to probable increased condition budget needs, the potential failure of its components, or in order to meet the performance Guidelines for this system. The system was installed in 1965. It has a 30-year service life which expired in 1995.

Location: Building B
Distress: Beyond Expected Life
Category: Deferred Maintenance
Priority: 3 - Short Term Conditions (2-3 Years)
Notes: Systems Testing & Balance, Beyond useful life. Rebalance system after system is renewed
Correction: Renew System
Qty: 1-Ea.
Condition Budget: \$63,908

Recommendation: The system should be replaced.

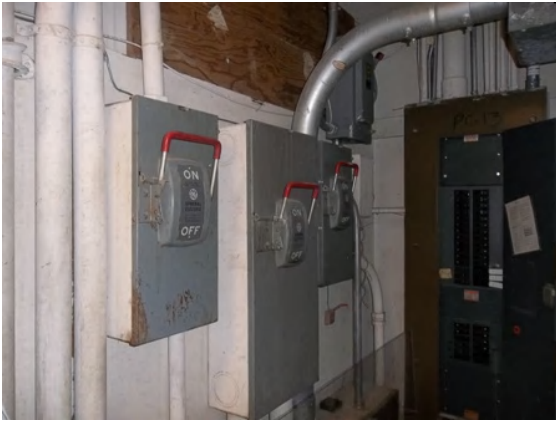
System: D5010 - Electrical Service/Distribution

Analysis: The system age is either beyond expected life or does not meet its intended performance under the Guidelines. The system may be in service and functioning but it is recommended to be replaced due to probable increased condition budget needs, the potential failure of its components, or in order to meet the performance Guidelines for this system. The system was installed in 1965. It has a 30-year service life which expired in 1995.

Notes: Electrical Service/ Distribution Systems beyond useful life. Replace

Recommendation: The system should be replaced.

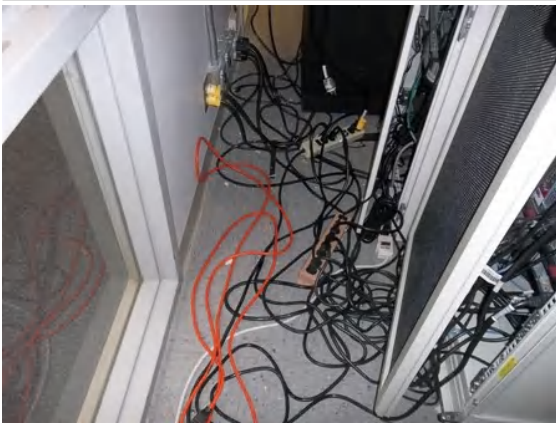
System: D5020 - Lighting and Branch Wiring

Analysis: The system age is either beyond expected life or does not meet its intended performance under the Guidelines. The system may be in service and functioning but it is recommended to be replaced due to probable increased condition budget needs, the potential failure of its components, or in order to meet the performance Guidelines for this system. The system was installed in 1965. It has a 30-year service life which expired in 1995.

Notes: Lighting and Branch Wiring System beyond useful life. Replace

Recommendation: The system should be replaced.

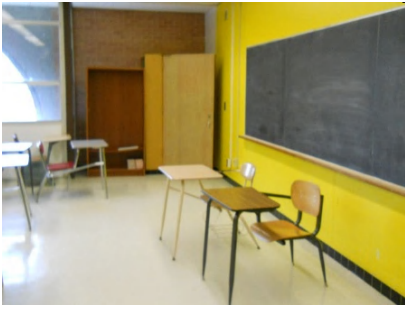
Analysis: The system age is either beyond expected life or does not meet its intended performance under the Guidelines. The system may be in service and functioning but it is recommended to be replaced due to probable increased condition budget needs, the potential failure of its components, or in order to meet the performance Guidelines for this system. The system was installed in 1965. It has a 20-year service life which expired in 1985.

Notes: Fixed Furnishings System beyond useful life.
Replace

Recommendation: The system should be replaced.

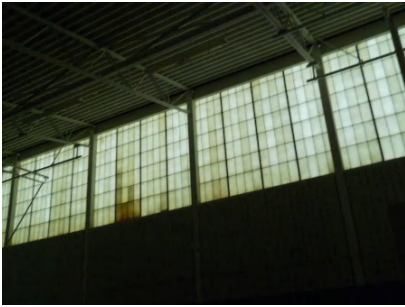
Analysis: The system age is either beyond expected life or does not meet its intended performance under the Guidelines. The system may be in service and functioning but it is recommended to be replaced due to probable increased condition budget needs, the potential failure of its components, or in order to meet the performance Guidelines for this system. The system was installed in 1965. It has a 30-year service life which expired in 1995.

Location: Building C
Distress: Beyond Expected Life
Category: Deferred Maintenance
Priority: 3 - Short Term Conditions (2-3 Years)
Notes: Exterior Windows System beyond useful life.
Replace

Recommendation: The system should be replaced.

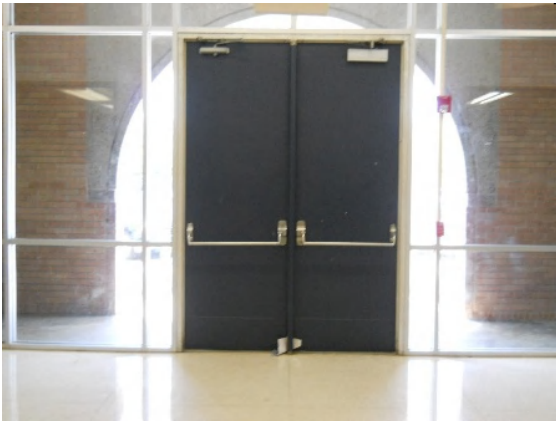
System: B2030 - Exterior Doors

Analysis: The system age is either beyond expected life or does not meet its intended performance under the Guidelines. The system may be in service and functioning but it is recommended to be replaced due to probable increased condition budget needs, the potential failure of its components, or in order to meet the performance Guidelines for this system. The system was installed in 1965. It has a 30-year service life which expired in 1995.

Location: Building C
Distress: Beyond Expected Life
Category: Deferred Maintenance
Priority: 3 - Short Term Conditions (2-3 Years)
Notes: Exterior Doors System beyond useful life. Replace

Recommendation: The system should be replaced.

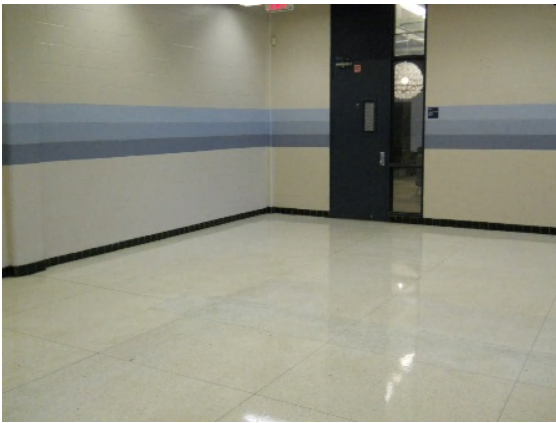
System: C1020 - Interior Doors

Analysis: The system age is either beyond expected life or does not meet its intended performance under the Guidelines. The system may be in service and functioning but it is recommended to be replaced due to probable increased condition budget needs, the potential failure of its components, or in order to meet the performance Guidelines for this system. The system was installed in 1965. It has a 20-year service life which expired in 1985.

Notes: Interior Doors System beyond useful life. Replace

Recommendation: The system should be replaced.

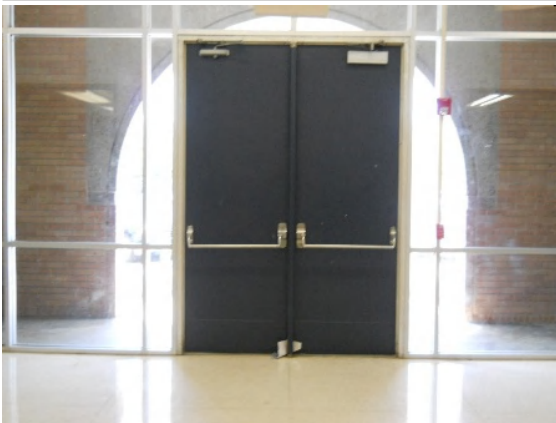
System: C1030 - Fittings

Analysis: The system age is either beyond expected life or does not meet its intended performance under the Guidelines. The system may be in service and functioning but it is recommended to be replaced due to probable increased condition budget needs, the potential failure of its components, or in order to meet the performance Guidelines for this system. The system was installed in 1965. It has a 15-year service life which expired in 1980.

Notes: Fittings System beyond useful life. Replace

Recommendation: The system should be replaced.

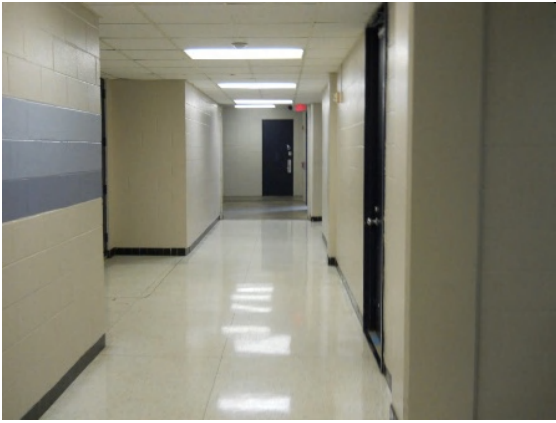
System: C3010 - Wall Finishes

Analysis: The system age is either beyond expected life or does not meet its intended performance under the Guidelines. The system may be in service and functioning but it is recommended to be replaced due to probable increased condition budget needs, the potential failure of its components, or in order to meet the performance Guidelines for this system. The system was installed in 1998. It has a 10-year service life which expired in 2008.

Notes: Wall Finishes System beyond useful life. Replace

Recommendation: The system should be replaced.

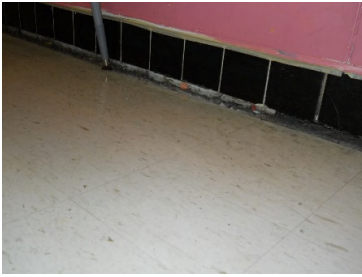
Location: Building C
Distress: Beyond Expected Life
Category: Deferred Maintenance
Priority: 3 - Short Term Conditions (2-3 Years)
Notes: VCT System beyond useful life. Replace
Correction: Renew System
Qty: 1-Ea.
Condition Budget: \$333,044

Recommendation: The system should be replaced.

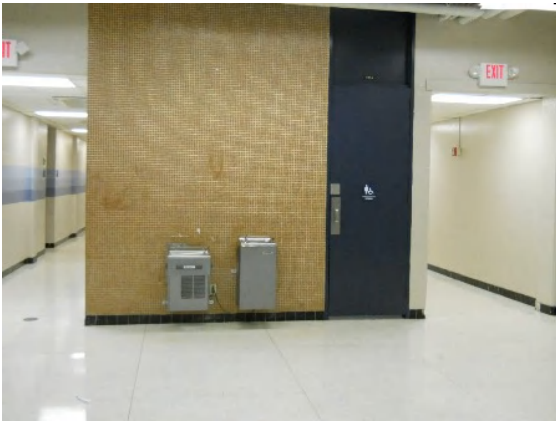
System: D2010 - Plumbing Fixtures

Analysis: The system age is either beyond expected life or does not meet its intended performance under the Guidelines. The system may be in service and functioning but it is recommended to be replaced due to probable increased condition budget needs, the potential failure of its components, or in order to meet the performance Guidelines for this system. The system was installed in 1965. It has a 30-year service life which expired in 1995.

Recommendation: The system should be replaced.

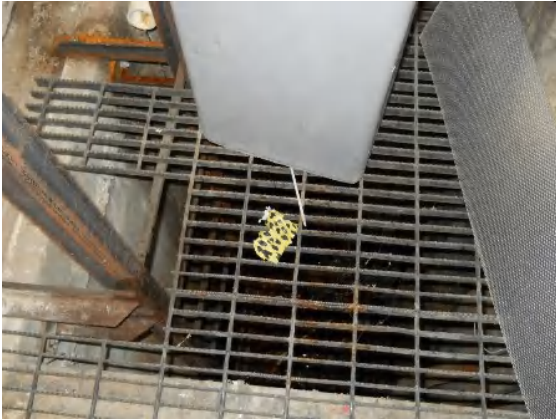
System: D2030 - Sanitary Waste

Analysis: The system age is either beyond expected life or does not meet its intended performance under the Guidelines. The system may be in service and functioning but it is recommended to be replaced due to probable increased condition budget needs, the potential failure of its components, or in order to meet the performance Guidelines for this system. The system was installed in 1965. It has a 30-year service life which expired in 1995.

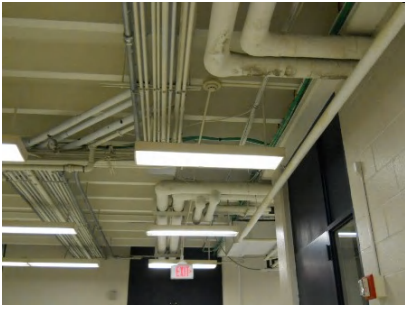
Location: Building C
Distress: Beyond Expected Life
Category: Deferred Maintenance
Priority: 3 - Short Term Conditions (2-3 Years)
Notes: Other Plumbing Systems-Nat Gas beyond useful life. Replace
Correction: Renew System
Qty: 1-Ea.
Condition Budget: \$39,661

Recommendation: The system should be replaced.

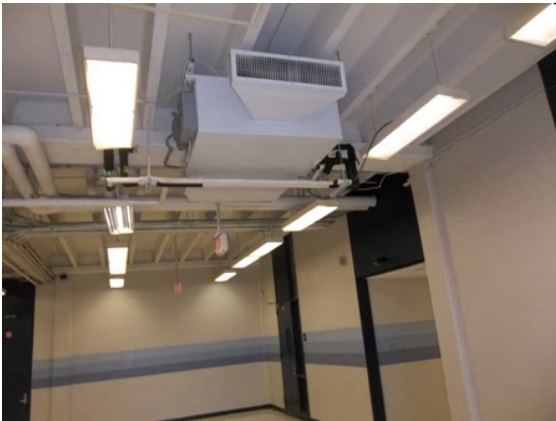
System: D3070 - Systems Testing & Balance

Analysis: The system age is either beyond expected life or does not meet its intended performance under the Guidelines. The system may be in service and functioning but it is recommended to be replaced due to probable increased condition budget needs, the potential failure of its components, or in order to meet the performance Guidelines for this system. The system was installed in 1965. It has a 30-year service life which expired in 1995.

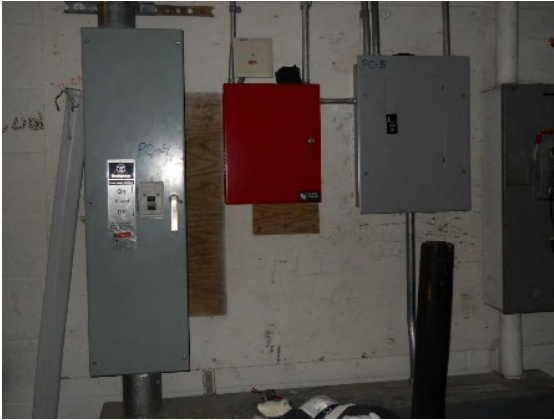
System: D5010 - Electrical Service/Distribution

Analysis: The system age is either beyond expected life or does not meet its intended performance under the Guidelines. The system may be in service and functioning but it is recommended to be replaced due to probable increased condition budget needs, the potential failure of its components, or in order to meet the performance Guidelines for this system. The system was installed in 1965. It has a 30-year service life which expired in 1995.

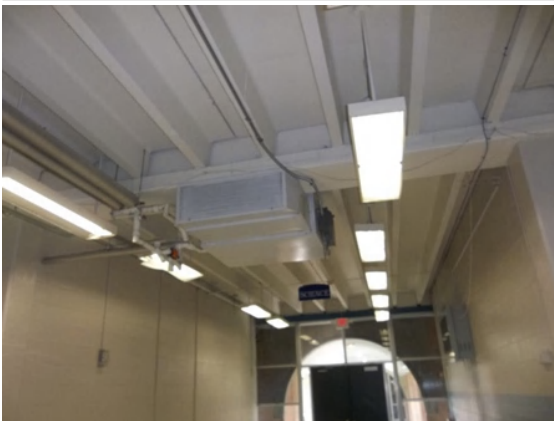
System: D5020 - Lighting and Branch Wiring

Analysis: The system age is either beyond expected life or does not meet its intended performance under the Guidelines. The system may be in service and functioning but it is recommended to be replaced due to probable increased condition budget needs, the potential failure of its components, or in order to meet the performance Guidelines for this system. The system was installed in 1980. It has a 30-year service life which expired in 2010.

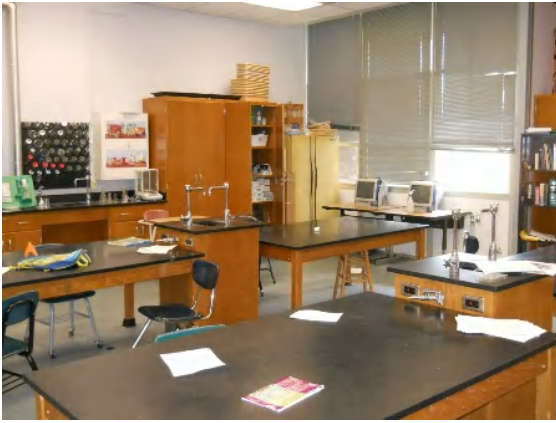
System: E2010 - Fixed Furnishings

Analysis: The system age is either beyond expected life or does not meet its intended performance under the Guidelines. The system may be in service and functioning but it is recommended to be replaced due to probable increased condition budget needs, the potential failure of its components, or in order to meet the performance Guidelines for this system. The system was installed in 1965. It has a 20-year service life which expired in 1985.

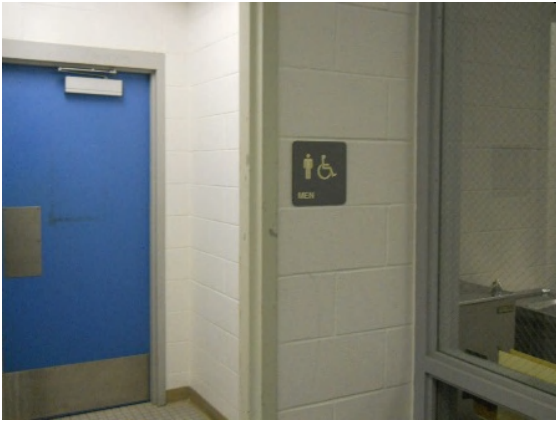
System: C1020 - Interior Doors

Analysis: The system age is either beyond expected life or does not meet its intended performance under the Guidelines. The system may be in service and functioning but it is recommended to be replaced due to probable increased condition budget needs, the potential failure of its components, or in order to meet the performance Guidelines for this system. The system was installed in 1992. It has a 20-year service life. However, in the assessment, it was found to be currently deficient.

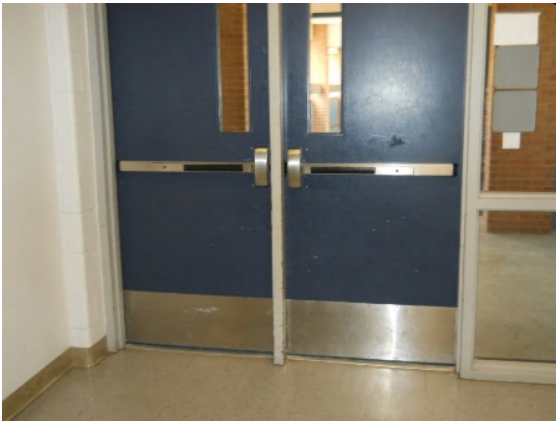
System: C1030 - Fittings

Analysis: The system age is either beyond expected life or does not meet its intended performance under the Guidelines. The system may be in service and functioning but it is recommended to be replaced due to probable increased condition budget needs, the potential failure of its components, or in order to meet the performance Guidelines for this system. The system was installed in 1992. It has a 15-year service life which expired in 2007.

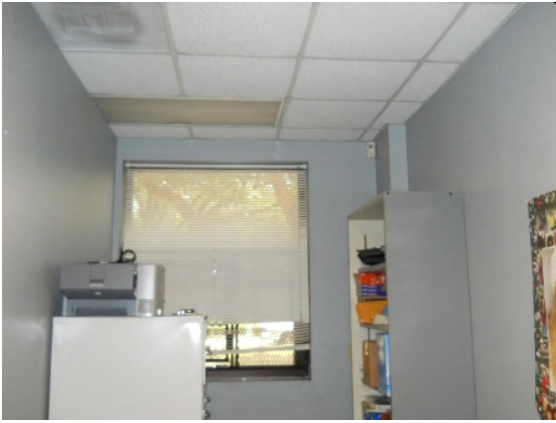
System: C3010 - Wall Finishes

Analysis: The system age is either beyond expected life or does not meet its intended performance under the Guidelines. The system may be in service and functioning but it is recommended to be replaced due to probable increased condition budget needs, the potential failure of its components, or in order to meet the performance Guidelines for this system. The system was installed in 1992. It has a 10-year service life which expired in 2002.

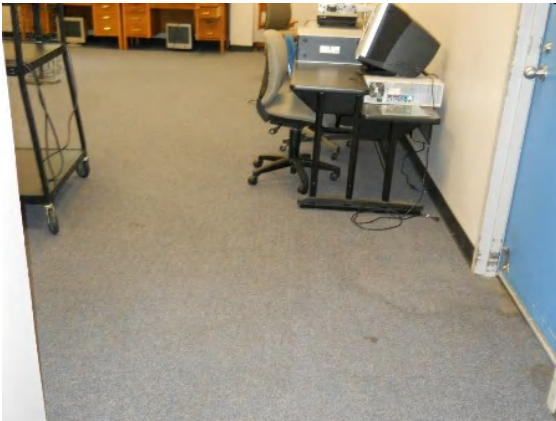
System: C3020210 - Carpet

Analysis: The system age is either beyond expected life or does not meet its intended performance under the Guidelines. The system may be in service and functioning but it is recommended to be replaced due to probable increased condition budget needs, the potential failure of its components, or in order to meet the performance Guidelines for this system. The system was installed in 1992. It has a 7-year service life which expired in 1999.

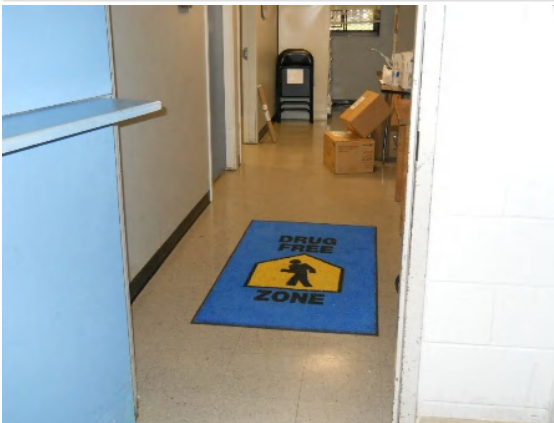
System: C3020410 - VCT

Analysis: The system age is either beyond expected life or does not meet its intended performance under the Guidelines. The system may be in service and functioning but it is recommended to be replaced due to probable increased condition budget needs, the potential failure of its components, or in order to meet the performance Guidelines for this system. The system was installed in 1992. It has a 0-year service life which expired in 1992.

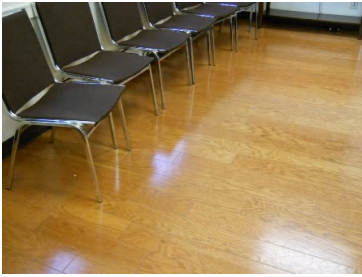
Location: Building D Main Office
Distress: Beyond Expected Life
Category: Deferred Maintenance
Priority: 3 - Short Term Conditions (2-3 Years)
Notes: Wood System beyond useful life. Replace
Correction: Renew System
Qty: 1-Ea.
Condition Budget: \$267,376

Recommendation: The system should be replaced.

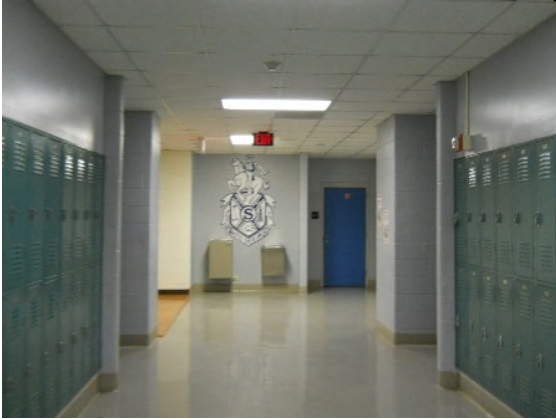
System: C3030 - Ceiling Finishes

Analysis: The system age is either beyond expected life or does not meet its intended performance under the Guidelines. The system may be in service and functioning but it is recommended to be replaced due to probable increased condition budget needs, the potential failure of its components, or in order to meet the performance Guidelines for this system. The system was installed in 1992. It has a 20-year service life. However, in the assessment, it was found to be currently deficient.

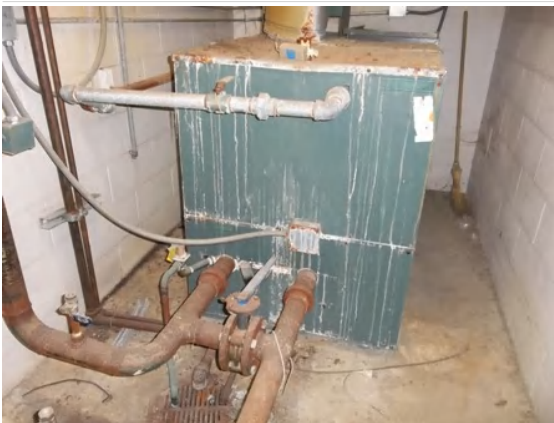
System: D3020 - Heat Generating Systems

Analysis: The system age is either beyond expected life or does not meet its intended performance under the Guidelines. The system may be in service and functioning but it is recommended to be replaced due to probable increased condition budget needs, the potential failure of its components, or in order to meet the performance Guidelines for this system. The system was installed in 1983. It has a 20-year service life which expired in 2003.

Priority: 3 - Short Term Conditions (2-3 Years)

Recommendation: The system should be replaced.

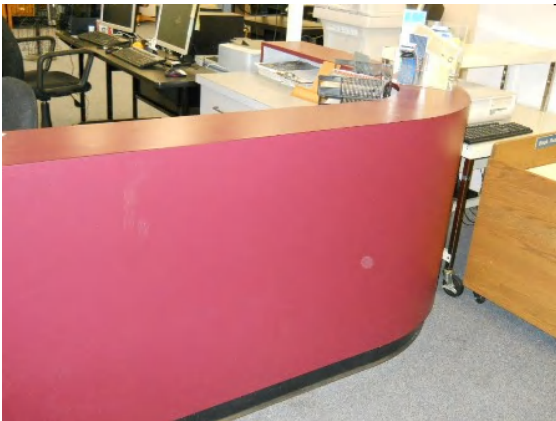
System: E2010 - Fixed Furnishings

Analysis: The system age is either beyond expected life or does not meet its intended performance under the Guidelines. The system may be in service and functioning but it is recommended to be replaced due to probable increased condition budget needs, the potential failure of its components, or in order to meet the performance Guidelines for this system. The system was installed in 1992. It has a 20-year service life. However, in the assessment, it was found to be currently deficient.

Priority: 3 - Short Term Conditions (2-3 Years)

Notes: Fixed Furnishings System beyond useful life.
Replace

Recommendation: The system should be replaced.

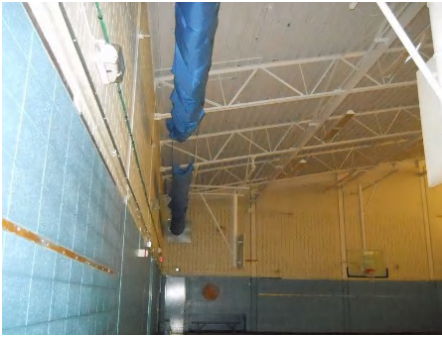
Location: Building E Gymnasium
Distress: Beyond Expected Life
Category: Deferred Maintenance
Priority: 3 - Short Term Conditions (2-3 Years)
Notes: Ceiling Finishes System Beyond Useful life.
Replace

Recommendation: The system should be replaced.

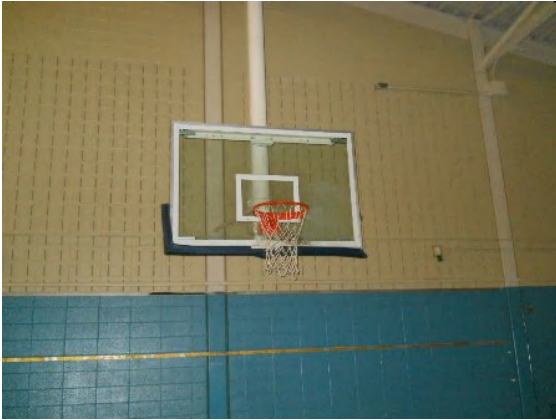
System: E2010 - Fixed Furnishings

Analysis: The system age is either beyond expected life or does not meet its intended performance under the Guidelines. The system may be in service and functioning but it is recommended to be replaced due to probable increased condition budget needs, the potential failure of its components, or in order to meet the performance Guidelines for this system. The system was installed in 1983. It has a 0-year service life which expired in 1983.
