School Assessment Report

Type: High Schools
School: Worthing High School
Date: Jul 16, 2012

School Name: Worthing High School

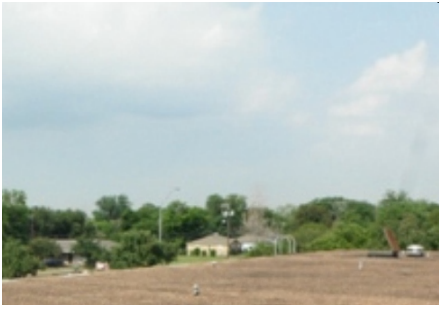
Analysis: The system age is either beyond expected life or does not meet its intended performance under the Guidelines. The system may be in service and functioning but it is recommended to be replaced due to probable increased condition budget needs, the potential failure of its components, or in order to meet the performance Guidelines for this system. The system was installed in 1980. It has a 30-year service life which expired in 2010.

Recommendation: The system should be replaced.

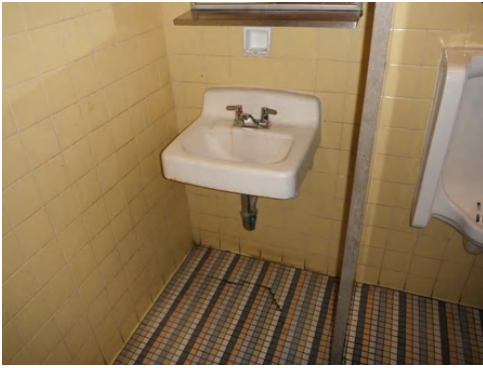
Analysis: The system age is either beyond expected life or does not meet its intended performance under the Guidelines. The system may be in service and functioning but it is recommended to be replaced due to probable increased condition budget needs, the potential failure of its components, or in order to meet the performance Guidelines for this system. The system was installed in 1981. It has a 30-year service life which expired in 2011.

Recommendation: The system should be replaced.

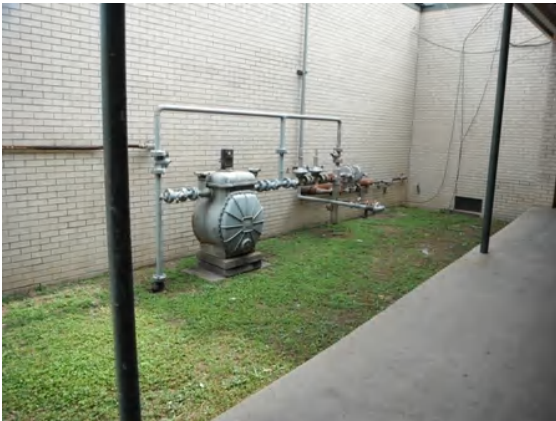
System: D2090 - Other Plumbing Systems-Nat Gas

Analysis: The system age is either beyond expected life or does not meet its intended performance under the Guidelines. The system may be in service and functioning but it is recommended to be replaced due to probable increased condition budget needs, the potential failure of its components, or in order to meet the performance Guidelines for this system. The system was installed in 1981. It has a 20-year service life which expired in 2001.

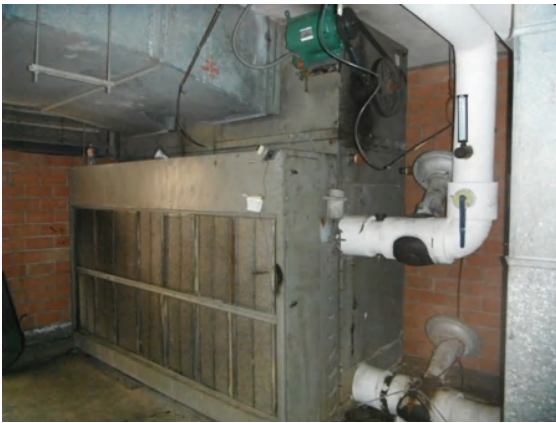
System: D3040 - Distribution Systems

Analysis: The system age is either beyond expected life or does not meet its intended performance under the Guidelines. The system may be in service and functioning but it is recommended to be replaced due to probable increased condition budget needs, the potential failure of its components, or in order to meet the performance Guidelines for this system. The system was installed in 1981. It has a 30-year service life which expired in 2011.

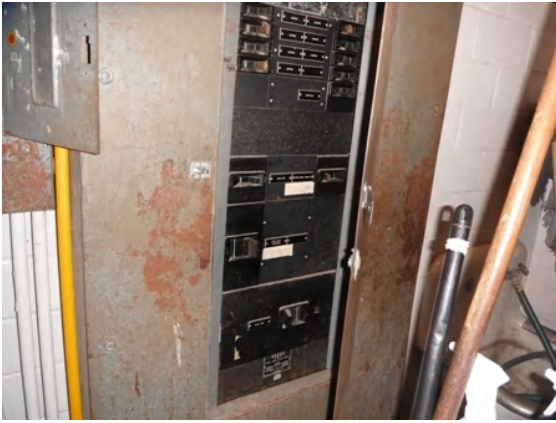
System: D5020 - Lighting and Branch Wiring

Analysis: The system age is either beyond expected life or does not meet its intended performance under the Guidelines. The system may be in service and functioning but it is recommended to be replaced due to probable increased condition budget needs, the potential failure of its components, or in order to meet the performance Guidelines for this system. The system was installed in 1959. It has a 30-year service life which expired in 1989.

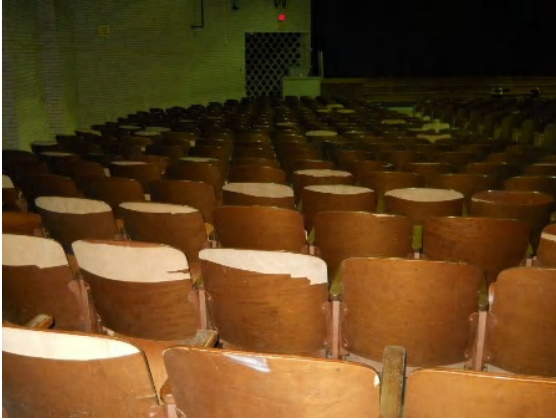
System: E2010 - Fixed Furnishings

Analysis: The system age is either beyond expected life or does not meet its intended performance under the Guidelines. The system may be in service and functioning but it is recommended to be replaced due to probable increased condition budget needs, the potential failure of its components, or in order to meet the performance Guidelines for this system. The system was installed in 1959. It has a 20-year service life which expired in 1979.
