School Assessment Report

Type: High Schools
School: Yates High School
Date: Jul 16, 2012

Final

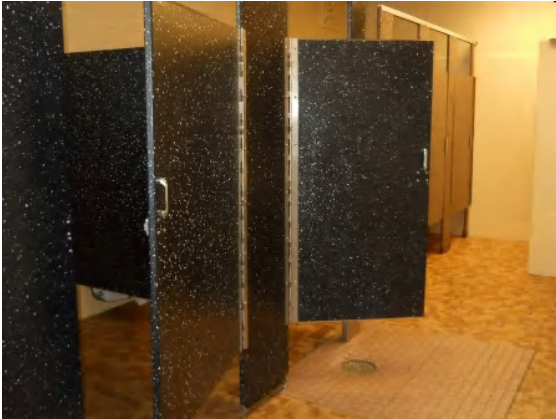
System: C1030 - Fittings

Analysis: The system age is either beyond expected life or does not meet its intended performance under the Guidelines. The system may be in service and functioning but it is recommended to be replaced due to probable increased condition budget needs, the potential failure of its components, or in order to meet the performance Guidelines for this system. The system was installed in 1958. It has a 20-year service life which expired in 1978.

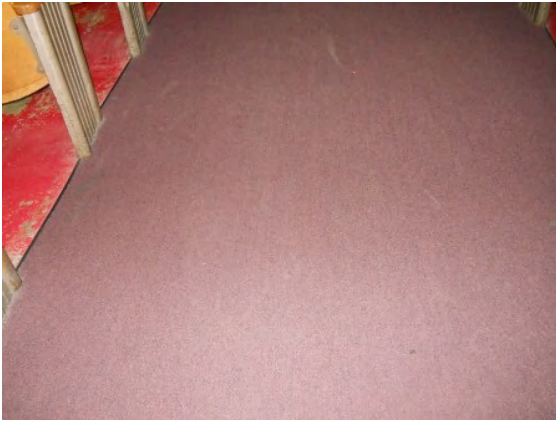
System: C3020210 - Carpet

Analysis: The system age is either beyond expected life or does not meet its intended performance under the Guidelines. The system may be in service and functioning but it is recommended to be replaced due to probable increased condition budget needs, the potential failure of its components, or in order to meet the performance Guidelines for this system. The system was installed in 1986. It has a 15-year service life which expired in 2001.

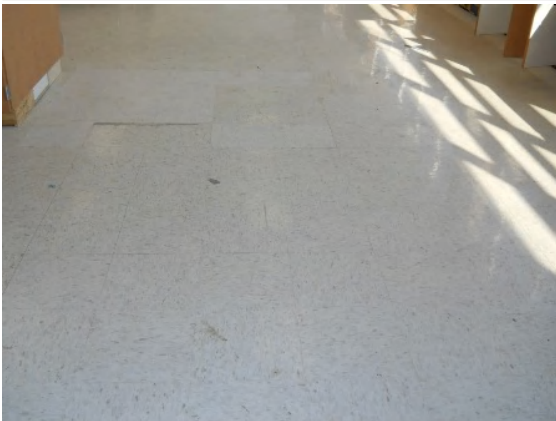
System: C3020410 - VCT

Analysis: The system age is either beyond expected life or does not meet its intended performance under the Guidelines. The system may be in service and functioning but it is recommended to be replaced due to probable increased condition budget needs, the potential failure of its components, or in order to meet the performance Guidelines for this system. The system was installed in 1986. It has a 15-year service life which expired in 2001.

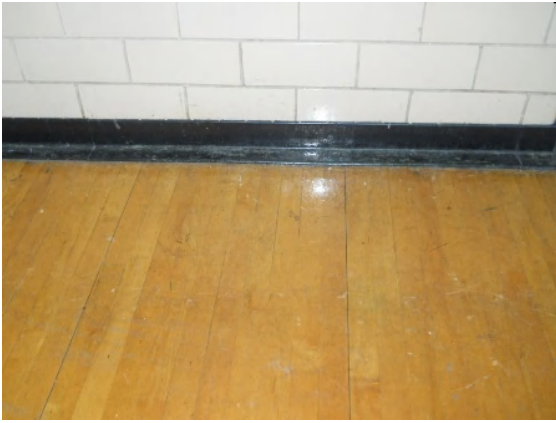
System: C3020410 - Wood

Analysis: The system age is either beyond expected life or does not meet its intended performance under the Guidelines. The system may be in service and functioning but it is recommended to be replaced due to probable increased condition budget needs, the potential failure of its components, or in order to meet the performance Guidelines for this system. The system was installed in 1958. It has a 30-year service life which expired in 1988.

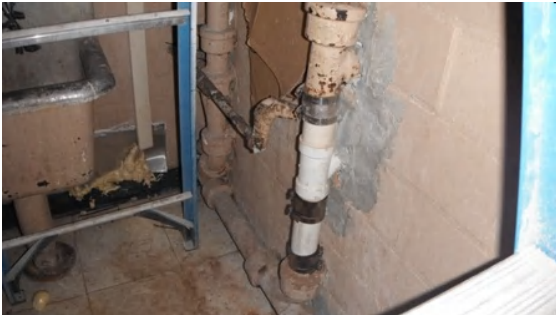
System: D2020 - Domestic Water Distribution

Analysis: The system age is either beyond expected life or does not meet its intended performance under the Guidelines. The system may be in service and functioning but it is recommended to be replaced due to probable increased condition budget needs, the potential failure of its components, or in order to meet the performance Guidelines for this system. The system was installed in 1958. It has a 30-year service life which expired in 1988.

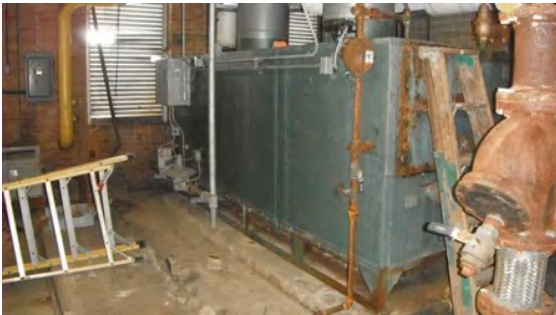
System: D3020 - Heat Generating Systems

Analysis: The system age is either beyond expected life or does not meet its intended performance under the Guidelines. The system may be in service and functioning but it is recommended to be replaced due to probable increased condition budget needs, the potential failure of its components, or in order to meet the performance Guidelines for this system. The system was installed in 1958. It has a 30-year service life which expired in 1988.

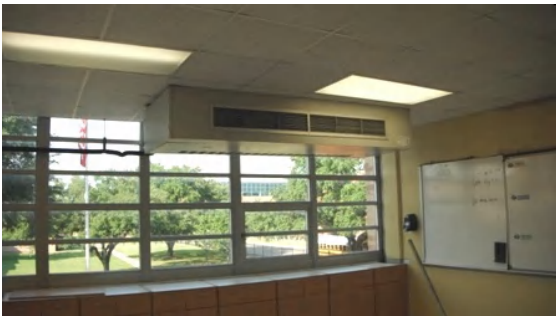
System: D3040 - Distribution Systems

Analysis: The system age is either beyond expected life or does not meet its intended performance under the Guidelines. The system may be in service and functioning but it is recommended to be replaced due to probable increased condition budget needs, the potential failure of its components, or in order to meet the performance Guidelines for this system. The system was installed in 1986. It has a 30-year service life. However, in the assessment, it was found to be currently deficient.

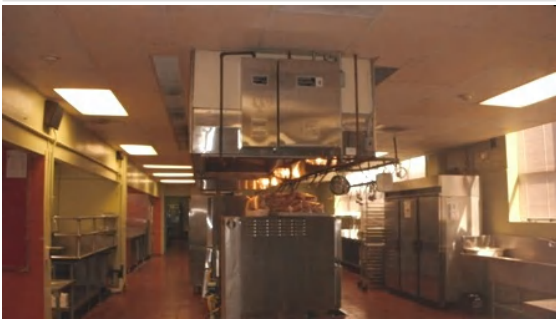
System: D4090 - Other Fire Protection Systems

Analysis: The system age is either beyond expected life or does not meet its intended performance under the Guidelines. The system may be in service and functioning but it is recommended to be replaced due to probable increased condition budget needs, the potential failure of its components, or in order to meet the performance Guidelines for this system. The system was installed in 1986. It has a 15-year service life which expired in 2001.

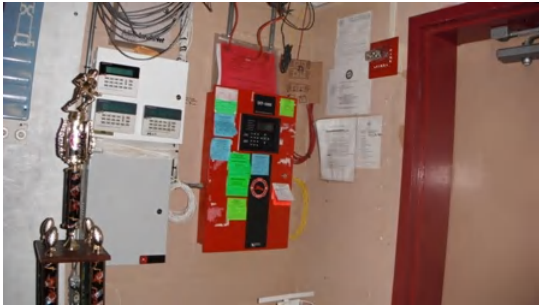
Location: Main
 Distress: Beyond Expected Life
 Category: Deferred Maintenance
 Priority: 3 - Short Term Conditions (2-3 Years)
 Notes: The fire alarm system is operable but beyond its expected service life and should be replaced.
 Correction: Renew System
 Qty: 1-Ea.
 Condition Budget: \$297,009

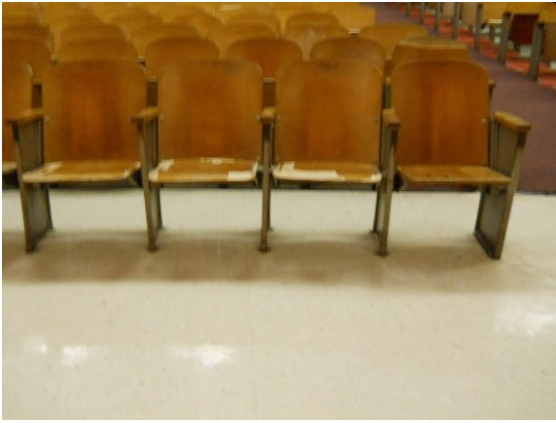
System: E2010 - Fixed Furnishings

Analysis: The system age is either beyond expected life or does not meet its intended performance under the Guidelines. The system may be in service and functioning but it is recommended to be replaced due to probable increased condition budget needs, the potential failure of its components, or in order to meet the performance Guidelines for this system. The system was installed in 1958. It has a 20-year service life which expired in 1978.

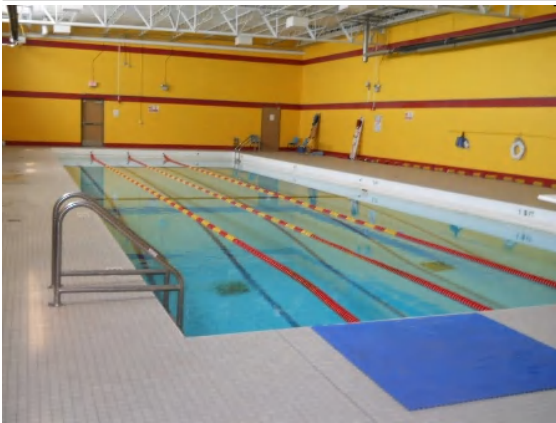
System: F1040 - Special Facilities - Pool Area

Analysis: The system age is either beyond expected life or does not meet its intended performance under the Guidelines. The system may be in service and functioning but it is recommended to be replaced due to probable increased condition budget needs, the potential failure of its components, or in order to meet the performance Guidelines for this system. The system was installed in 1958. It has a 20-year service life which expired in 1978.

Priority: 3 - Short Term Conditions (2-3 Years)

Recommendation: The system should be replaced.
